# Building Defects Inspection Report

This report was prepared May 7, 2012

Assessing the Maintenance Requirements  
for [ ] Condominium and Townhouses in  
Surrey, BC

Prepared for [ ] Property Management Inc.  
Vancouver, BC

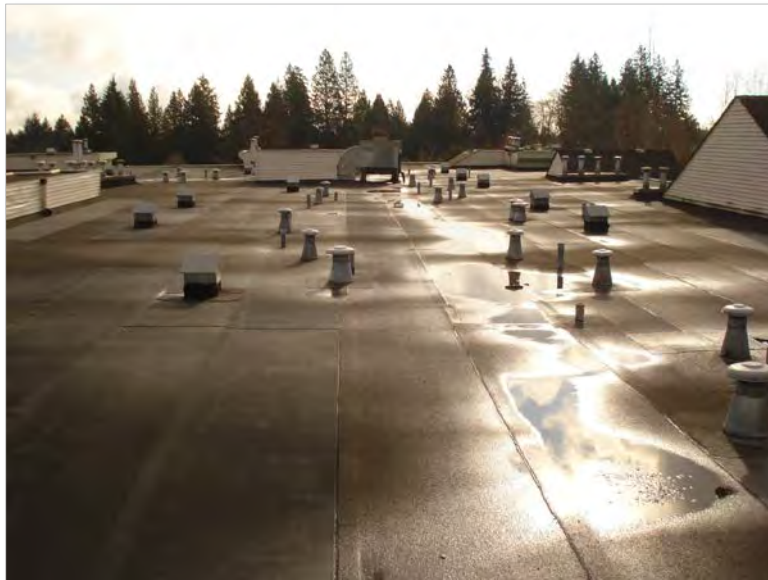
### Flat Roof

**The roof appears to be well maintained.** One of the first impressions is how clean and clear of debris the roof is. But, **the roof is aging and close to end of life.** We estimate 15% of the flat-roof has been patched to date, not unexpected on a roof now 17-18 years old.

There is no denying the conditions of numerous components of the roof are compromised. There are **clear signs of aging and significant**

**wear to the overall roof membrane.** Compromises include: little or no cover-gravel remaining, top layer of the membrane cracking, seams gapping, membrane soft-spots, lifting and ridging. There are a number of areas where water is pooling, unable to reach the drains; important because with little or no cover-gravel remaining, and the top-layer of the membrane starting to ridge and crack, it is assured the water-proof barrier is straining and at significant risk of penetration.

1. *Roof continue to be closely monitored for non-performing aspects*
2. *Further investigate those areas that appear to be non-performing and, if required, make appropriate repairs.*
3. *Begin planning and contingency funding NOW for an anticipated full re-roof of approximately 45,000-47,000 square feet within 3-5 years (or sooner). Costs will depend on type of membrane, sloping and drainage plain changes required and all related roof-side flashing and finishing details.*

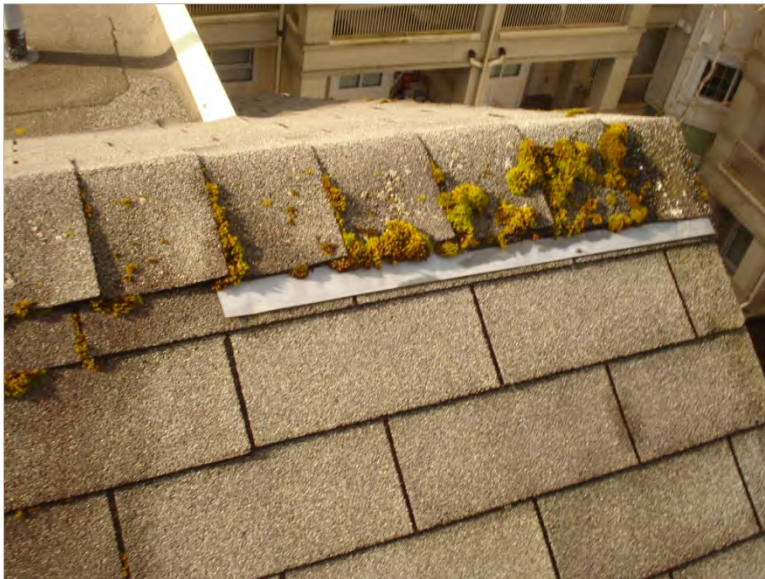
## Sloped Roofs

The sloped roofs of the gable-structures show similar wear. There is moss building up at many locations. A few small zinc strips to prevent moss growth have been installed, but show limited success mostly due to the limited size and locations of the zinc strips. There are a few areas where flashings to protect the fascia boards are not properly installed and water is penetrating the edges of OSB substrate beneath. There were

a couple of spots where the roof membrane was not even covering the substrate. A couple of locations have cavities where birds will be entering and nesting under the roofline, within the gable structure.

4. *Roof continue to be closely monitored for non-performing aspects*
5. *Further investigate those areas that appear to be non-performing and, if required, make appropriate repairs.*
6. *Inspect the roof attics for proper ventilation and envelope performance.*
7. *Begin contingency funding NOW for an anticipated full re-roof within 3-5 years or sooner.*

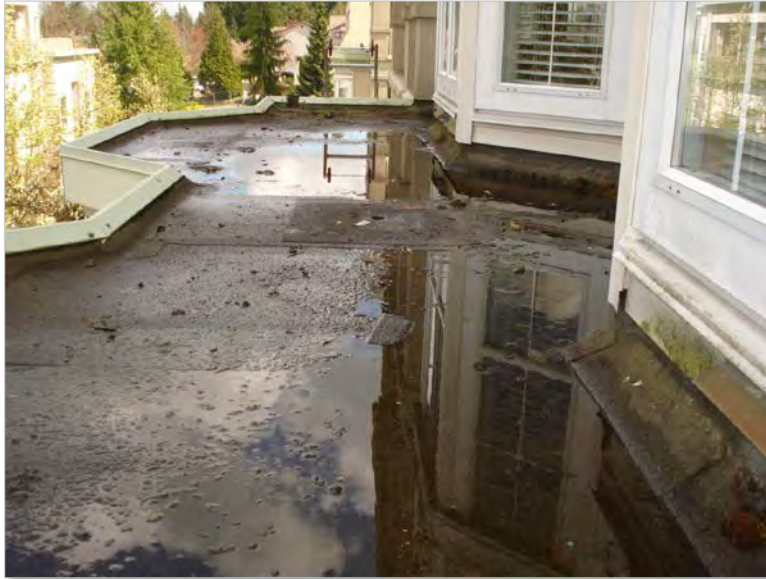
## First Floor Canopy Roofs

There is evidence of a lot of moisture at the soffit panels, below some of the first floor portico roofs. Most likely this is coming from water entering via a failed roof membrane above.

This is most likely caused by a problem with negative roof sloping on the short portico rooflines. Negative roof slopes are where the roof slopes the opposite direction of the drain locations allowing water to remain pooled. Negative sloping may have occurred due

to un-equal settling and shrinkage of the canopy roof's two sides. The 4-story building's wall-side (right side of the picture) can shrink and settle more than the 1-story outside column-side (left side of the picture). Over time, the proper slope reverses towards the opposite direction. The constantly pooled water is causing wear and permeation issues to the roof membrane. Repair will likely require "re-sloping" the roofs prior to re-covering them.

1. *Investigate the full extent of the problem.*
2. *Re slope the rooflines so the water drains properly.*
3. *Replace roof membranes as necessary.*
4. *Adjust for any other drain or drainage issues.*
5. *Remediate any damage moisture may have caused to the roof's wood structure.*

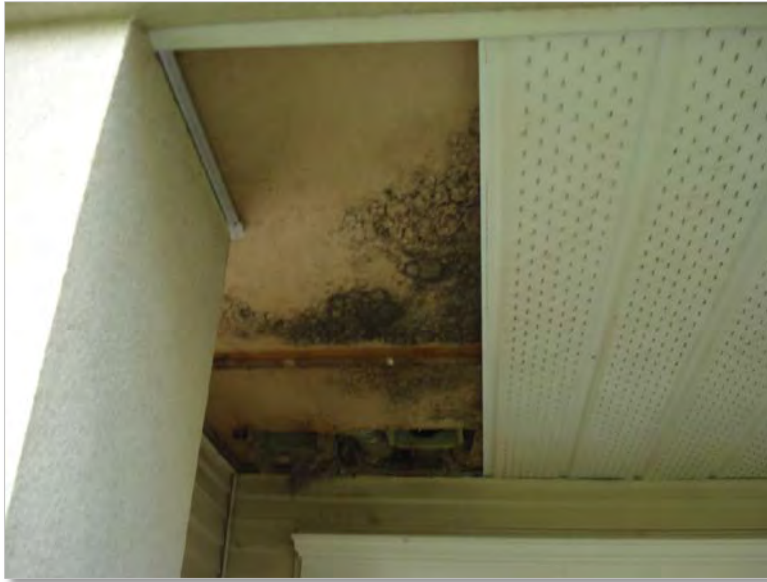
## Soffits above the Exterior Living Spaces (Decks)

One of the most troubling findings was heavy mold and mildew growth due to excessive moisture in some of the deck soffits.

We noted a number of soffit covers yellowing at the air holes and found excessive moisture accumulating. We opened up only one soffit location and found the extent of the moisture and mold problem fairly extreme.

And, there may be more than one source of the moisture ingress into the soffit space. Potentially, it could be caused by a **leak in the above decking membrane**. It also may be caused by **moisture from interior air exhaust being vented through the soffit** structure including moist air from bathrooms and moist lint-laden air from clothes dryers. And, to exacerbate matters, the method used to satisfy the exterior living space (deck) fire-block requirements, a double sheet of standard gyproc fixed directly above the soffit metal, **completely blocks vital air-flow through the soffits**, eliminating air circulation and **capturing all the moisture within**.

A review of previous reports indicates this problem was noted and even predicted in those reports. Whether anything was done to address the concerns is not known, but from initial investigations, it would appear little or no remediation was under-taken.

1. *Investigate all soffit locations to determine the full extent of the problem.*
2. *Investigate different ways/materials to act as fire block.*
3. *Investigate best practices to ventilate the soffit areas.*
4. *Open all soffit locations and clean out all mold, mildew and decayed material*
5. *Repair all locations as per the recommendations of the intensive investigations.*

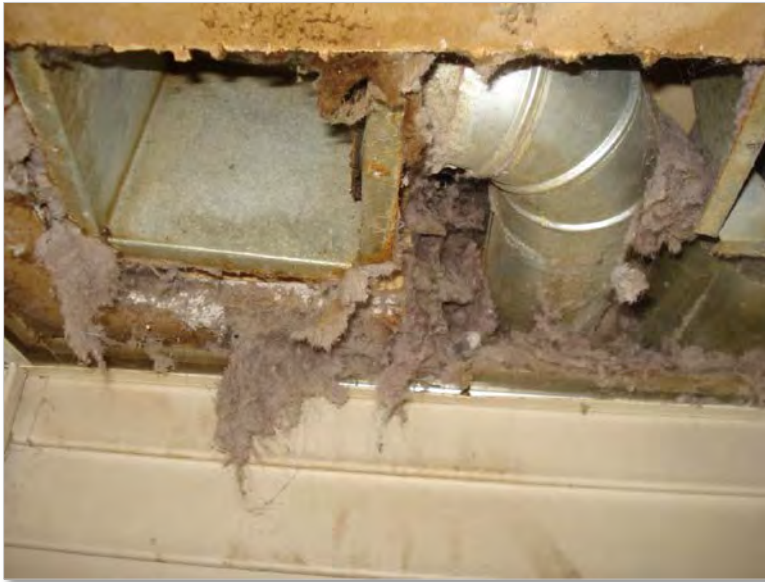
## Air Vents

Some of the venting systems that exhaust moist air from inside the living spaces are a concern. Lint accumulation and moisture retention were noted in more than one location and in some, the lint buildup is so severe, we question whether there is any lint filtration for the clothes dryer at all. And, to exacerbate the problem, many of those air vents are channeled to exit through the patio deck ceilings, which, as mentioned earlier, are poorly ventilated,

largely due to the existing double-gyproc fire-block system. In these cases, moist air is escaping into the soffit cavity and being captured to affect the building components: gyproc, wood framing and in many cases lint which has accumulated.

The accumulated lint acts like a sponge, soaking up the moisture and providing the perfect living conditions for mold and mildew. This will cause decay of the wood structure and is a potential health risk for those living within. In cases where there is significant buildup, the problem becomes acute and adds a potential risk of fire. We saw mold and mildew growth in a number of locations and believe there is similar potential in all locations. We recommend all soffit areas of the decks be investigated and remediated. We suggest all dryer vent covers be replaced with new covers that have spring loaded doors. Compromised dryer vents need to be cleaned and all owners reminded of the importance of the proper, regular use of kitchen grease filters and dryer lint filters.

1. *Clean all compromised vents areas of lint accumulation*
2. *Remind all residents to practice proper filtration.*
3. *Replace passive air vent caps with spring loaded caps to help reduce drafts and vermin.*

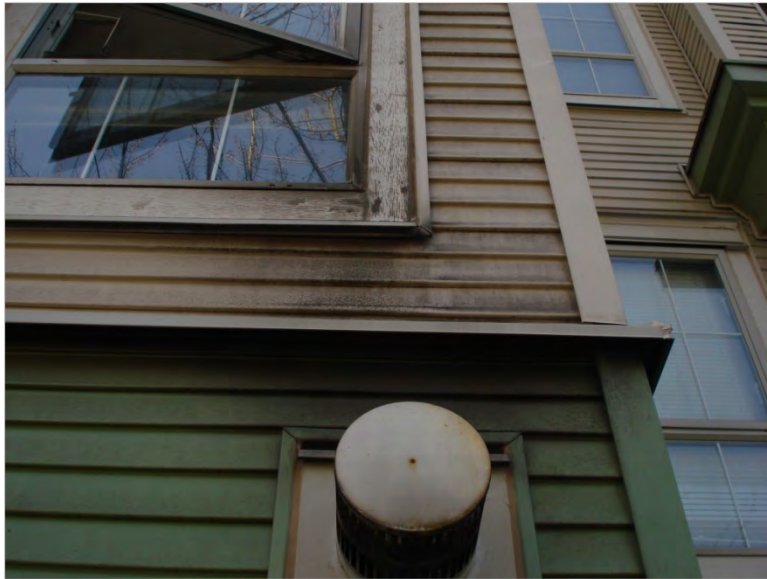
## Gas Vents

For the most part gas venting looked satisfactory, but there are some locations that exhibit exceptional build-up of exhaust soot on the walls above the vent. Most likely this is an indication of a fireplace requiring service. All fireplaces should be serviced every 2-3 years.

Some gas vents are also situated in very close proximity to windows that open allowing exhaust to easily enter the living space. A cursory review

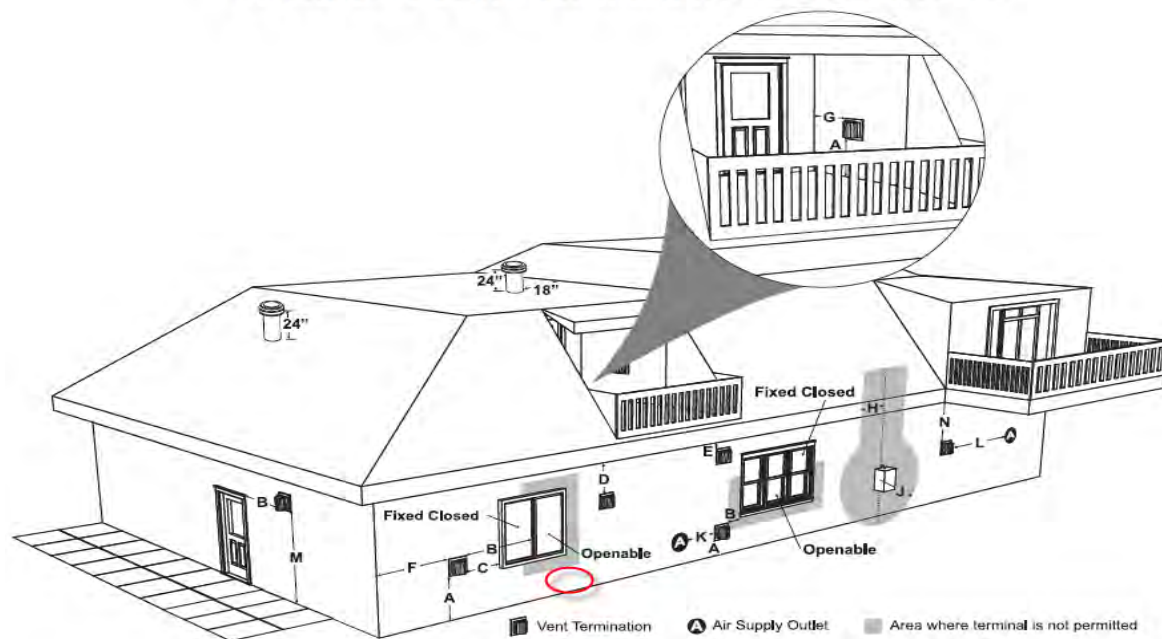
### EXTERIOR VENT TERMINATION LOCATIONS

Minimum clearance is 12" (30cm) from a window or door that may be opened. The window in question is approximately 36" (90cm). Grey areas above are the "no installation" zones. (Information provided by Regency P36D-1FireplaceInstallation Manual for Zero Clearance Direct Vent Gas Fireplaces in stated accordance with CSA B149.1, *Natural Gas and Propane Installation Code* and ANSI Z223.1/NFPA 54, *National Fuel Gas Code*, Page 21.)

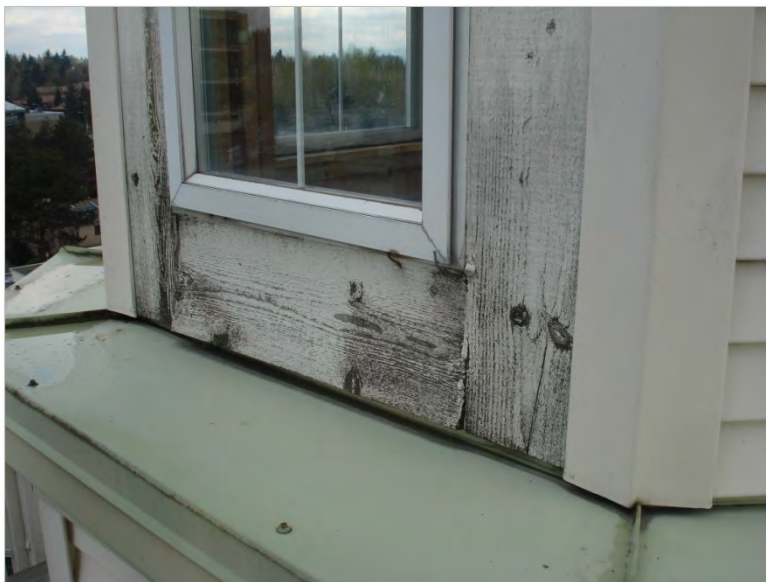
## Roof Turret

The roof has a decorative turret made up of windows, window trim and siding, with typical flashings and weather trim. The turret did not have the benefit of the window remediation conducted on the rest of the building a decade earlier. This enables us to see the effects of the weathering that the earlier remediation efforts prevented. It should be noted, this was constructed under building practices typical of the 1995 condo building era.

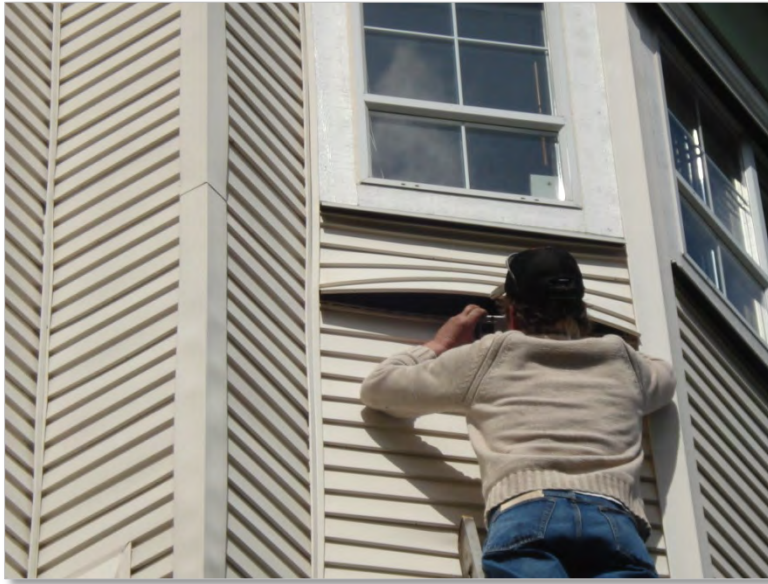
## Siding

For the most part the siding was performing as expected. There are a few locations where the siding has come un-attached, is slipping and needs to be re-attached. Considerable care should be taken to ensure the same pieces of siding can be re-installed. If the old siding needs to be replaced, a close match may be difficult to acquire.

Some of the metal Hurricane straps under the siding have bowed out because the

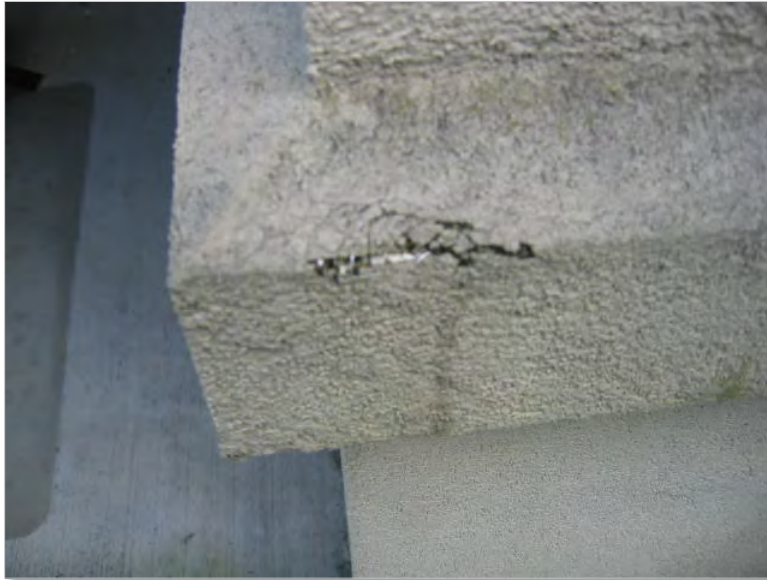
## Stucco

In a number of locations the protective stucco membrane has been broken allowing water to access the internal structural components.

1. *It is recommended all instances be repaired with an acrylic stucco to match.*

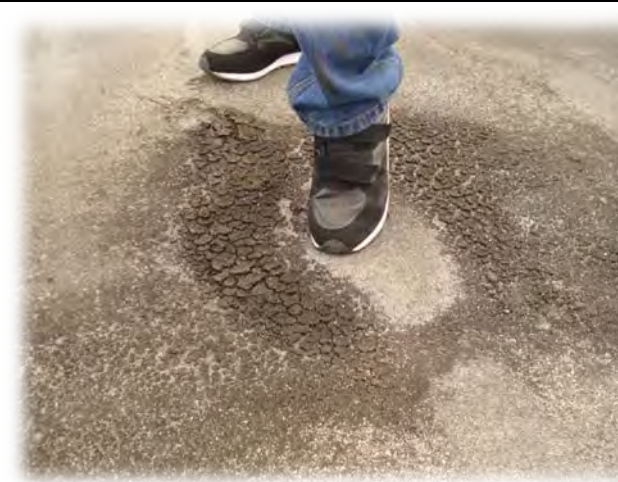
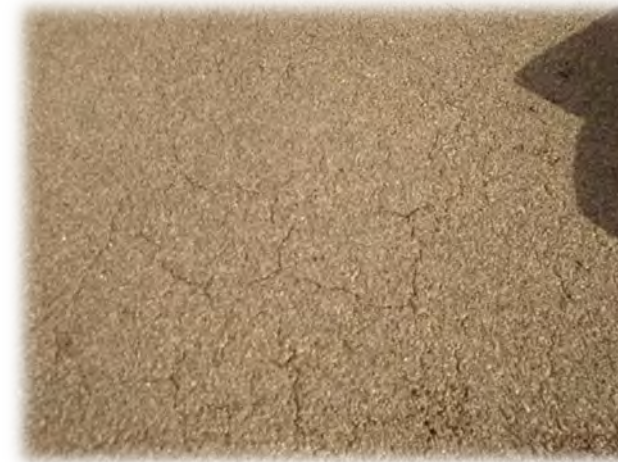
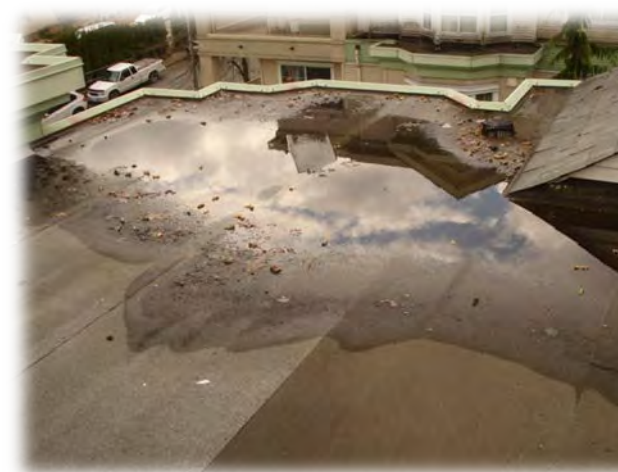
There are a number of places where water is pooling, unable to reach the drains. This is important because with little or no cover-gravel remaining, and the top-layer of the membrane starting to ridge and crack, it is assured the water-proof barrier beneath is straining and at significant risk of penetration.

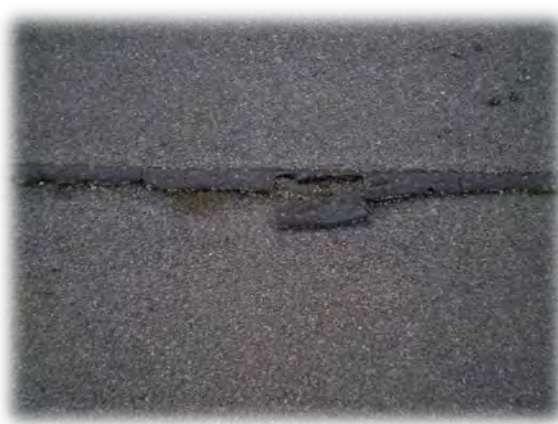
Seams between the bitumen rolls are dried out and many are brittle enough to begin breaking off making the seams vulnerable to water ingress beneath the membrane.

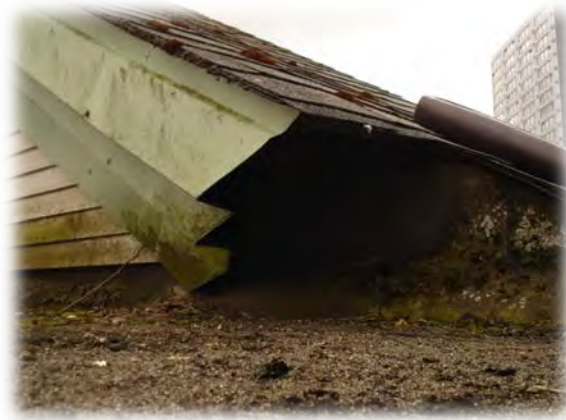
There were a couple of locations where an open cavity existed between gable building structure and the roof it was built on. These are vulnerable to birds and animals nesting and should be closed off for protection.

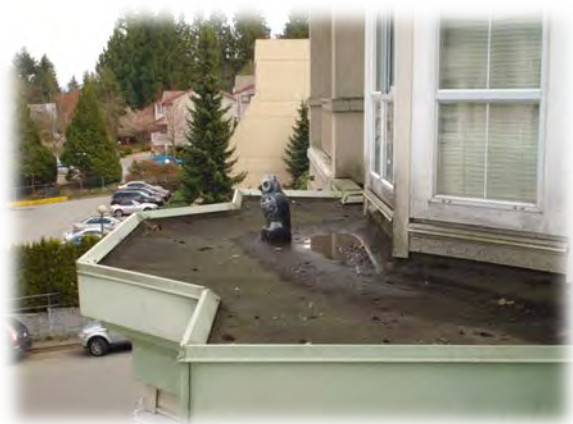
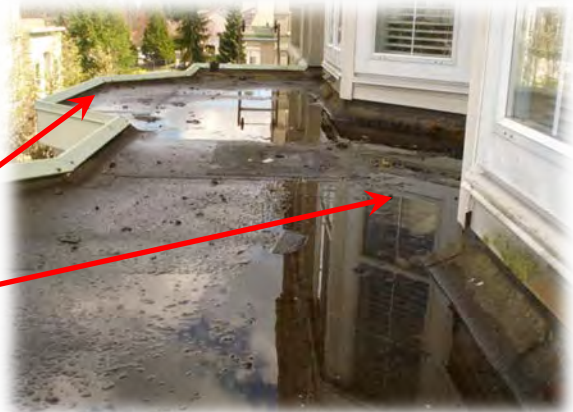
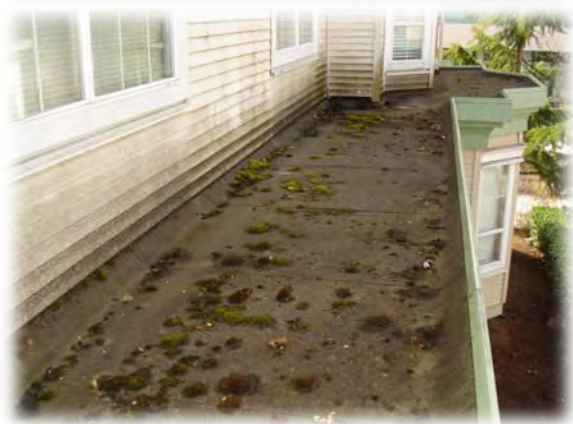
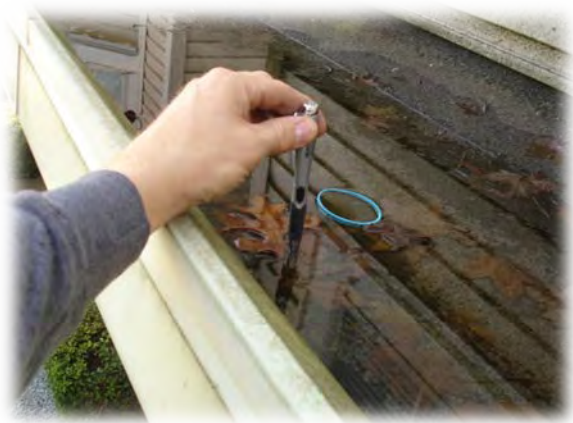
This roofline membrane is breached with water.

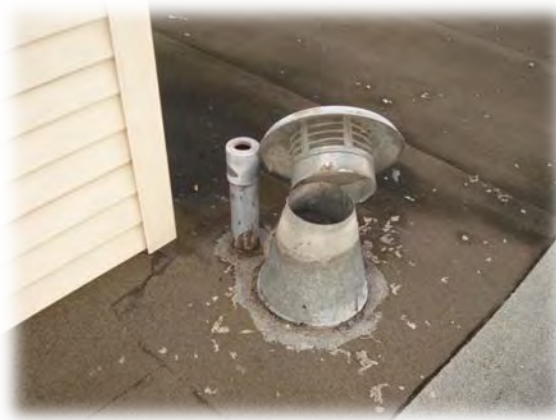
Vent caps off or mis-aligned such as this one on the roof.

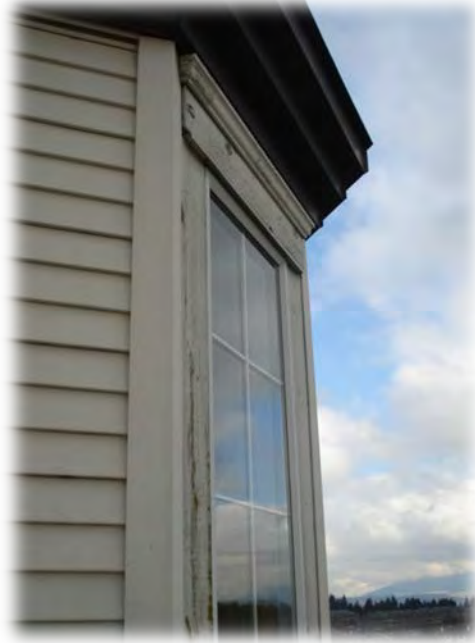
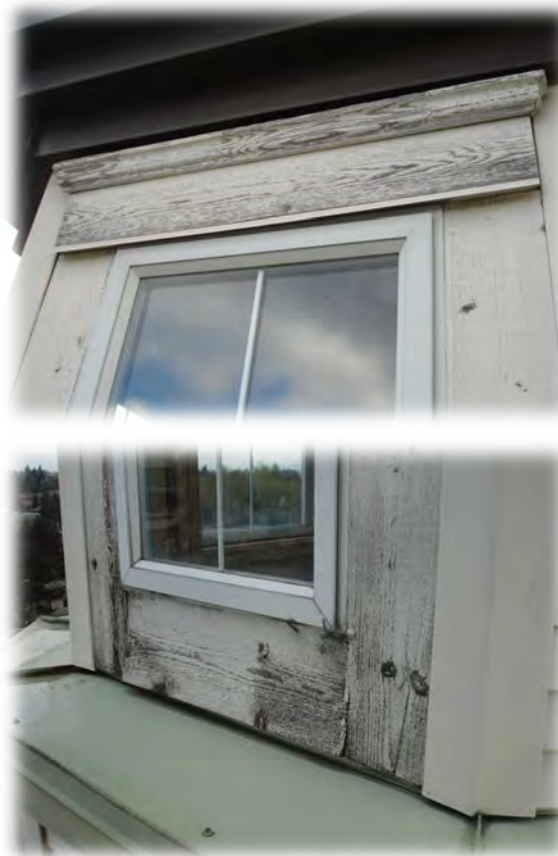
### Roof Turret

In the case of the turret, the windows, window flashings, siding and trim details need to be repaired in a similar fashion to the repairs done to the building's other windows.

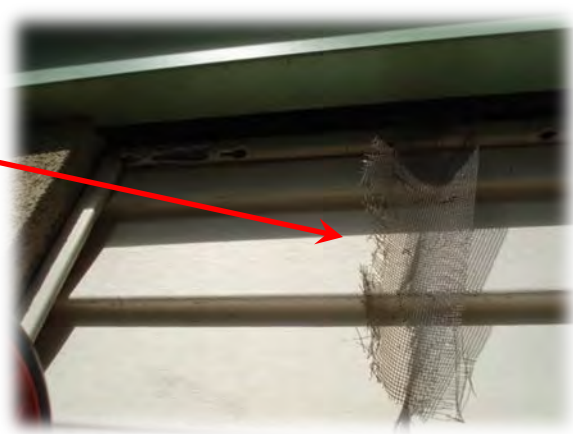
**SE Side:** Birds have picked out the insect screen from the rain-screen in the wall and also managed to pick holes in the J-Trim. **It is recommended the screen be replaced.** The holes should not present a functional problem.

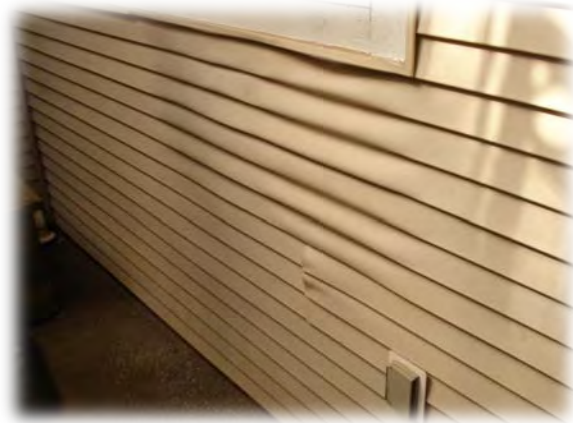
**SW Side:** A BBQ has melted the siding. In our opinion this may not have damaged the siding as a functional screen from weather or insects, but could be replaced for aesthetic purposes.

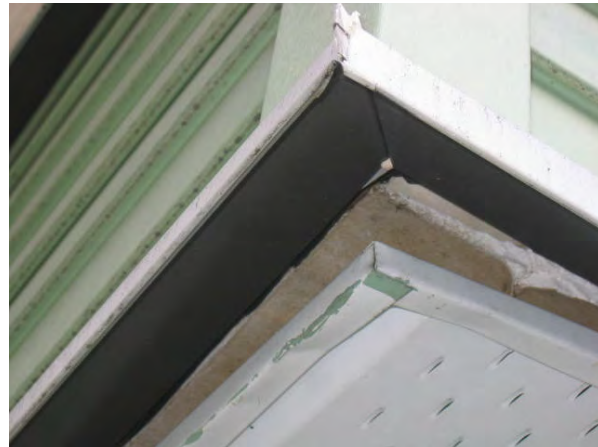
**NW Side:** 2<sup>nd</sup> floor bay window soffit is detached and needs to be reattached.

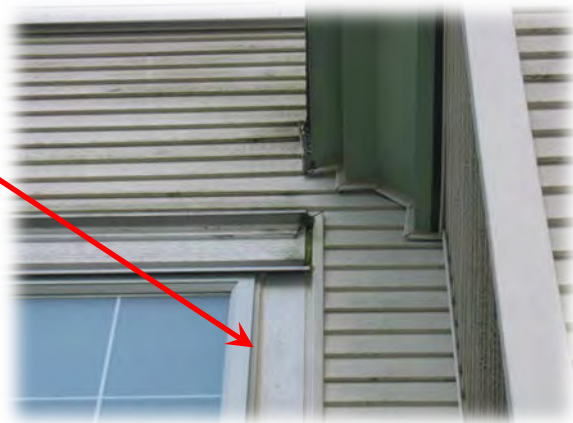
**NW Side:** 2<sup>nd</sup> floor window caulking not performing. Recommended cut out caulking and reseal.

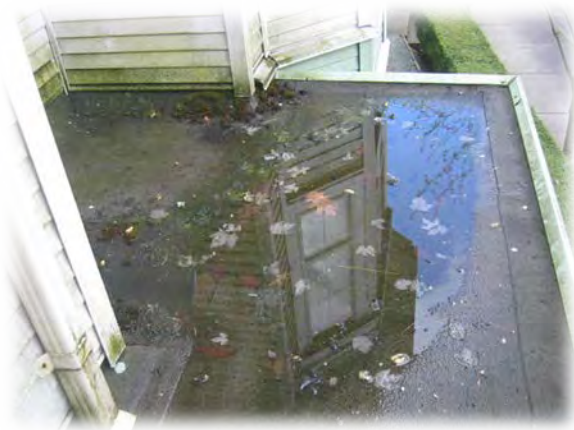
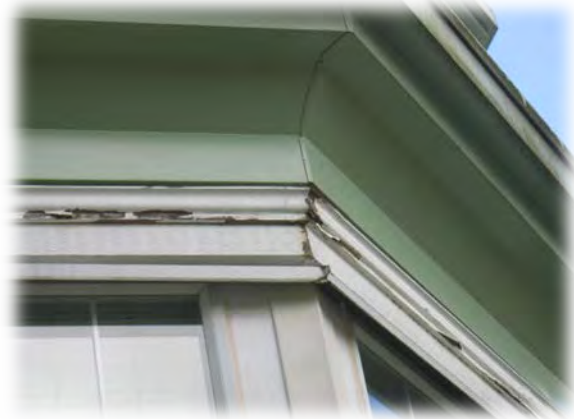
**NE Side:** Another instance of the *decorative crown molding above a 2<sup>nd</sup> floor window deteriorating due to poor paint and primer finish.* **It is recommended this be refinished to protect the wood from the weather and moisture.**

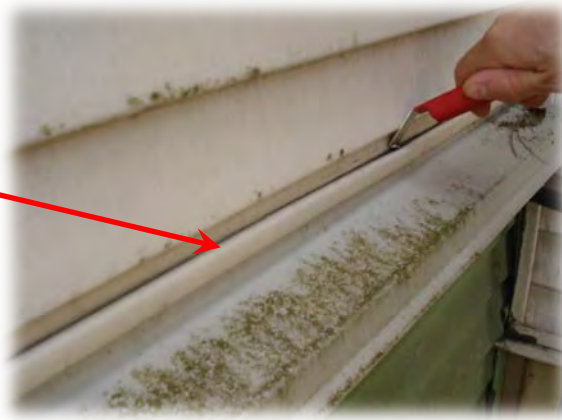
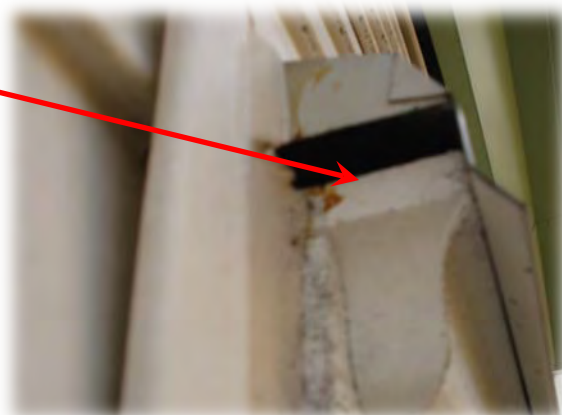
**West Side:** *End Dam flashing is exposing the wood trim detail which will begin to deteriorate if left exposed. Recommend the flashing be modified to cover the wood trim.*

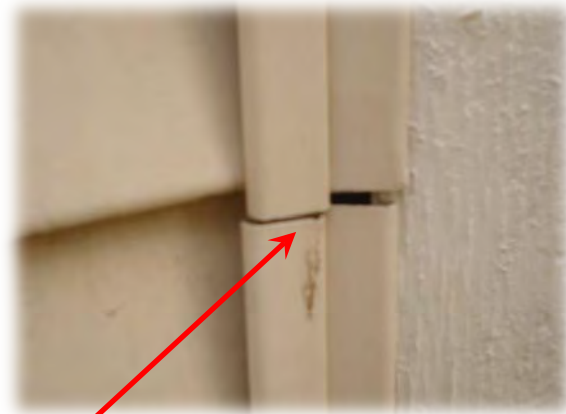
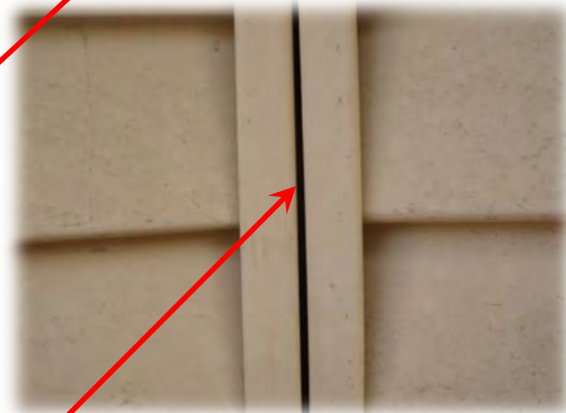
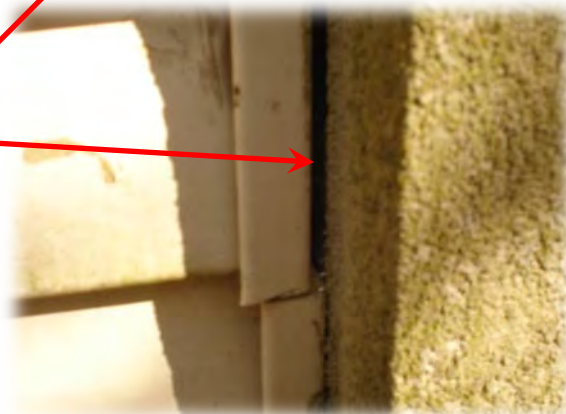
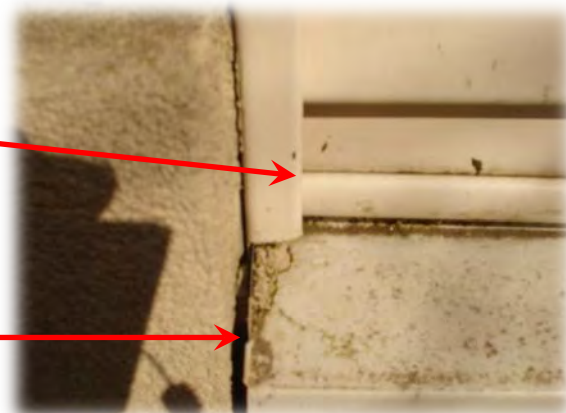
Caulking has let go between the flashing detail and the stucco.

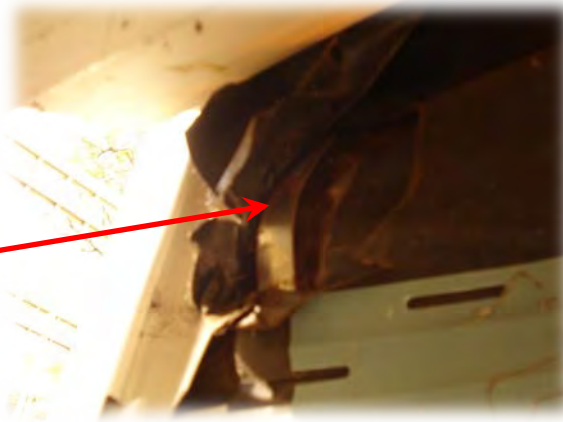
Another example of caulking details that have deteriorated leaving the flashing protection compromised.

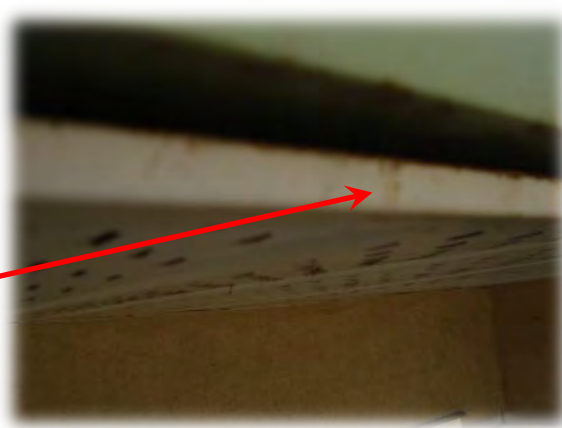
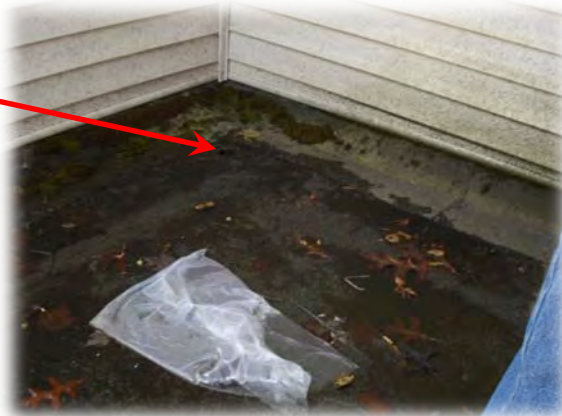
**NE Side:** *Some serious moisture problems were noted at the NE side of the building at Suite 112-113.*

The roof deck substrate is soft indicating the probable reason for the dripping of the soffits is water may be penetrating the roof membrane into the roof's building structure. **It is strongly recommended this be remediated immediately to ensure the damage does not persist and become worse. It is also recommended all similar portico roofs that show similar standing water and negative sloping be further investigation of similar water ingress problems or potential.**

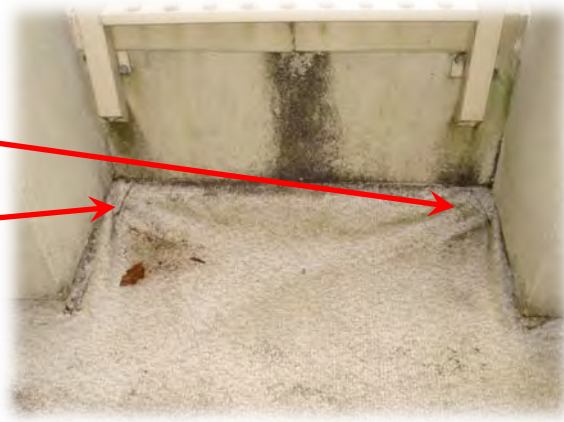
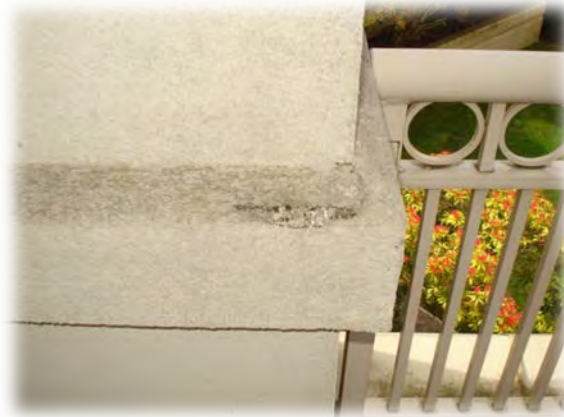
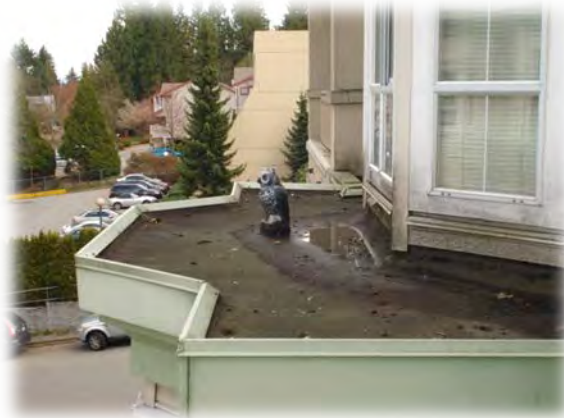
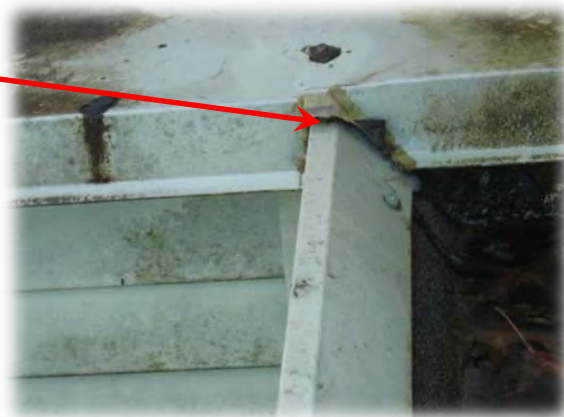
**Building 15268 NE Section North Side:**

Vinyl decking letting go. Recommend replacing with new vinyl.

Caulking is deteriorating on a flashing detail needing repair.

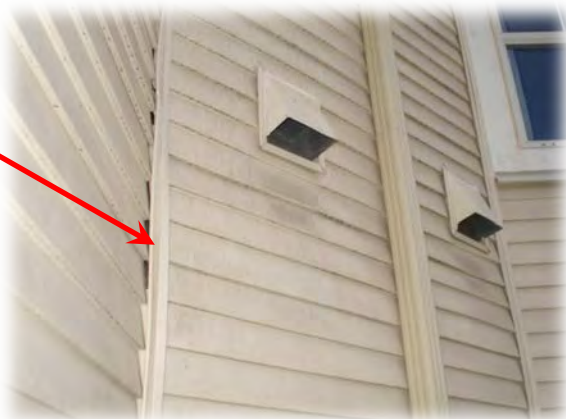
Hurricane straps are pushing siding out due to building shrinkage.

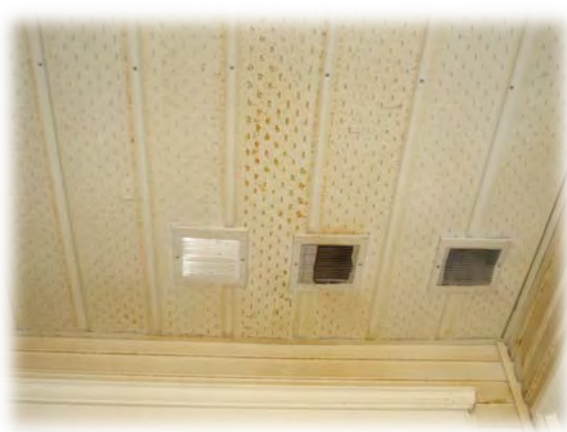
**Building 15268 Center Section East Side:**

Moisture trapped in soffit.

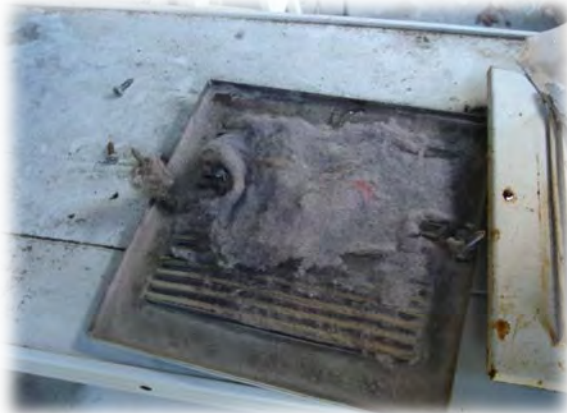
Dryer vent plugged adding moisture to the soffit structure..

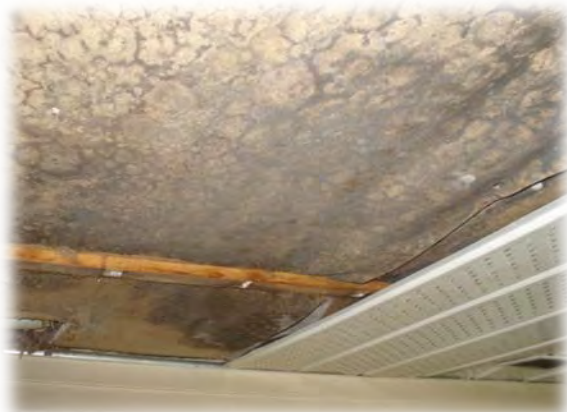
2<sup>nd</sup> floor deck fire blocking drywall under the soffit is water logged and has severe mold growth.

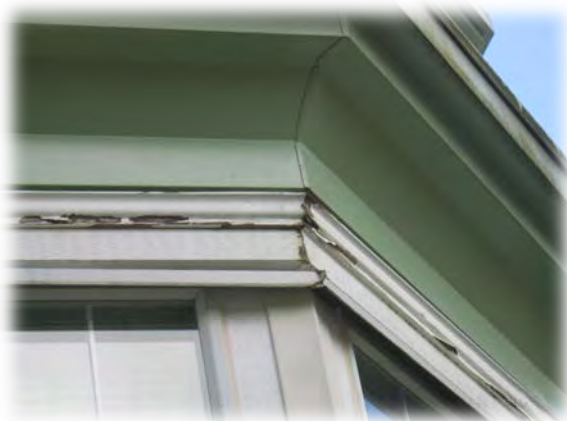
1<sup>st</sup> floor window trim decaying.

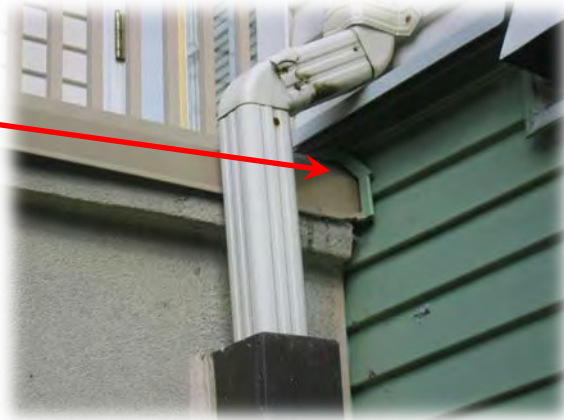
Caulking is missing at the base J-Molding and the cap flashing allowing water potentially behind the wall-envelope barrier.

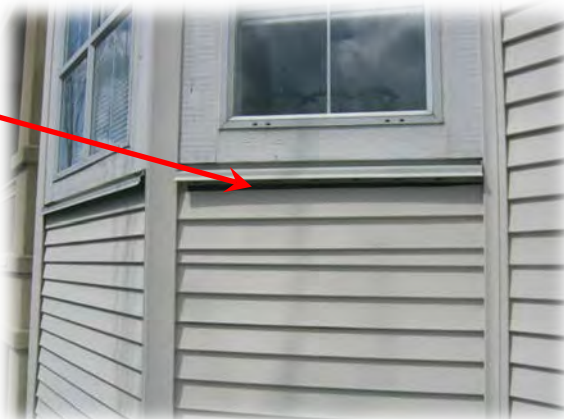
Siding slipped exposing the building paper.

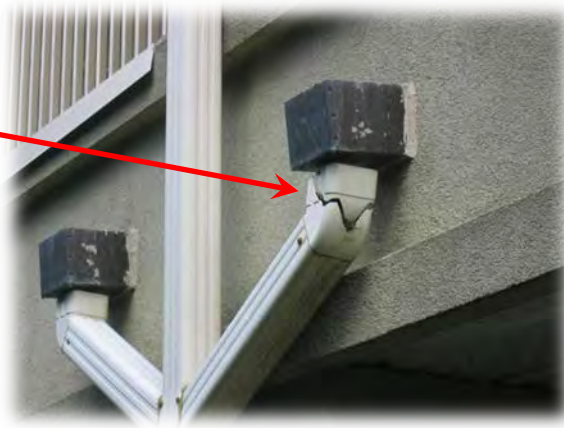
Broken drain downspout.

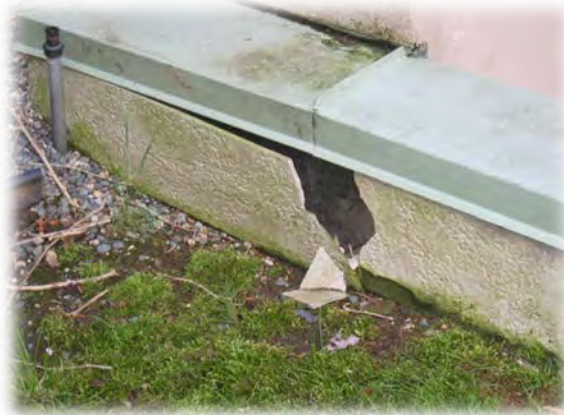
Broken hardi-board panel below lower metal flashing exposing water proof membrane.

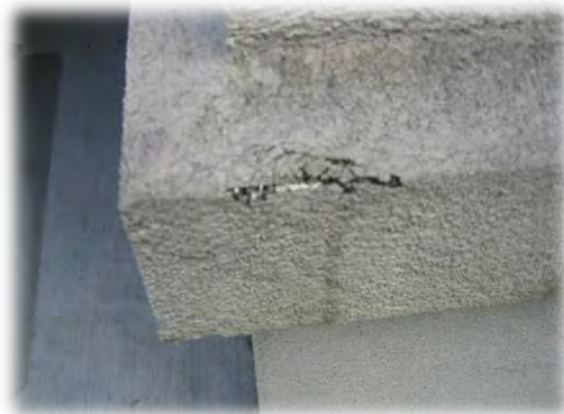
Numerous instances of need for repairs to the stucco finish.

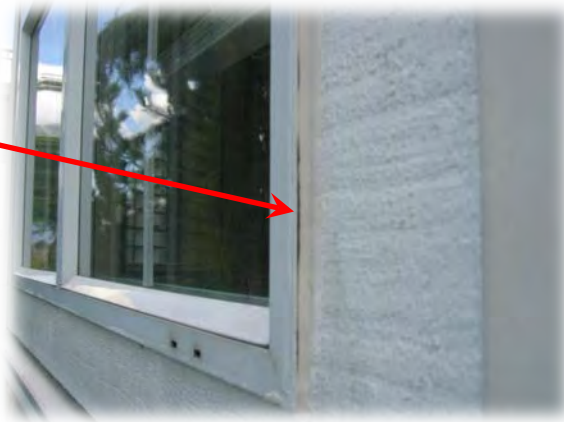
**Building 15268 West Side:**

Caulking separating on bay window of 3<sup>rd</sup> floor.

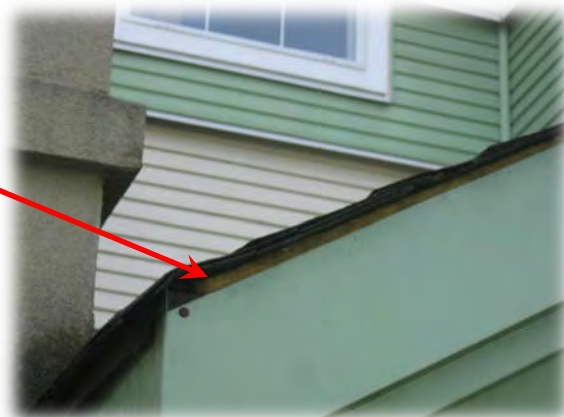
Roof substrate exposed where it rises above the metal flashing.
