# Building Maintenance Inspection Report

**Assessing the Maintenance Requirements  
for a High rise Tower  
in British Columbia**

**Prepared for Property Management Inc.**  
Vancouver, BC

... a residential, 24 story concrete high-rise located on the West Coast of BC, the east half tower of a two-tower development, completed in 1996 and now 16 years old.

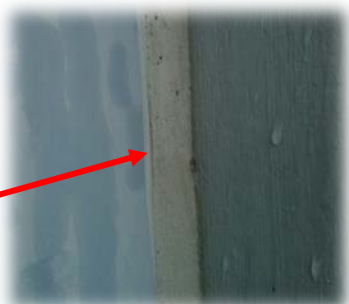
Sealant and Caulking Details	
<p>We observed the 16-year old sealant is in fair condition and to be, on average, at approximately 75% of its full live-span.</p> <p>Sealant bead-lines for concrete to flashing joints, as shown here, are typically <math>\frac{3}{4}</math>" in wide and holding relatively well.</p>

<p>These images indicate significant signs of sealant aging. They show a hardening and cracking of the sealant causing a separation of the sealant from the concrete to metal frame or metal frame to metal frame.</p> <p>These conditions are occurring in numerous places and indicate the sealant is nearing the end of its useful life. In many cases, as shown here, repair work is already required.</p> <p>It would be best if the building sealant in its entirety is dealt with, so situations as shown here do not occur elsewhere. There is significant indication that such occurrences will be happening more frequently in the near future.</p> <p>The only way to repair this properly is to cut out the existing sealant and spacer backing and replace it with new material.</p>

- *We recommend the entire building be re-caulked with new NP1 Sealant or its commercial equivalent. Applied properly, this would entail cutting out the old sealant and applying new backer-rod and new sealant.*

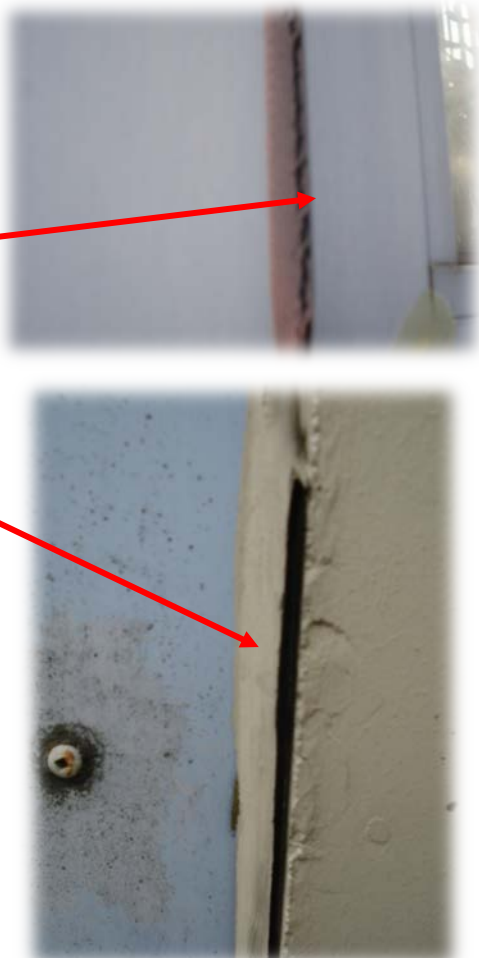
There are many examples of seam separation in the bay window units. These metal framing units are subject to a significant amount of expansion and contraction from heating and cooling which puts stress on the sealant.

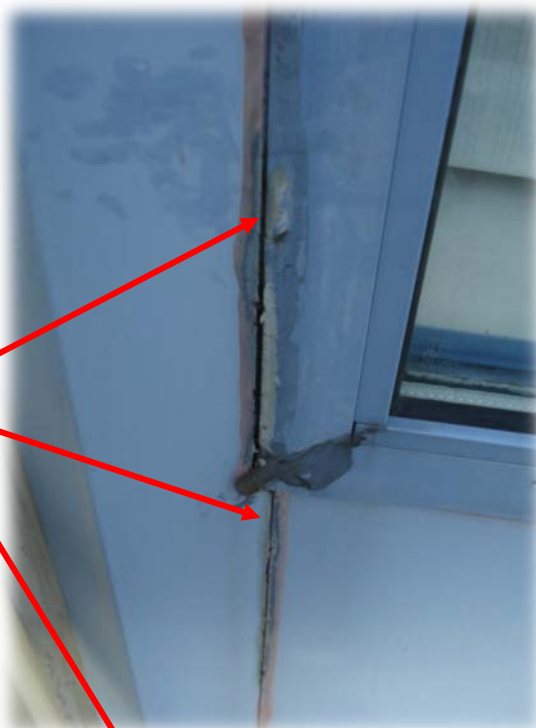
Moisture lodged within the separations freezes and expands creating further expansion.

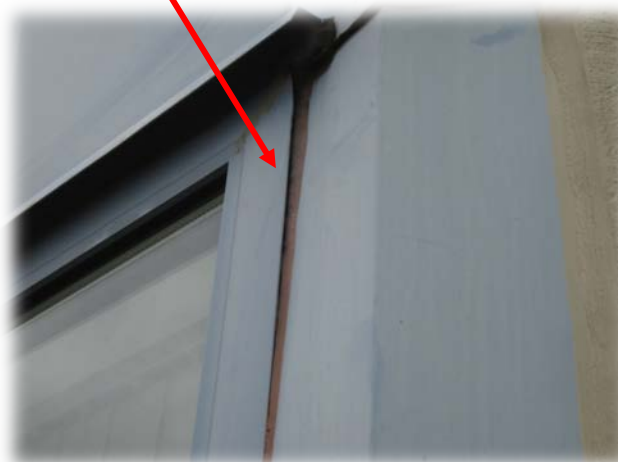
Additionally, mould and mildew can get into the spaces, colonize and further separate the spaces. Consequently, once the initial separation takes place, further expansion and separation, quickly follows.

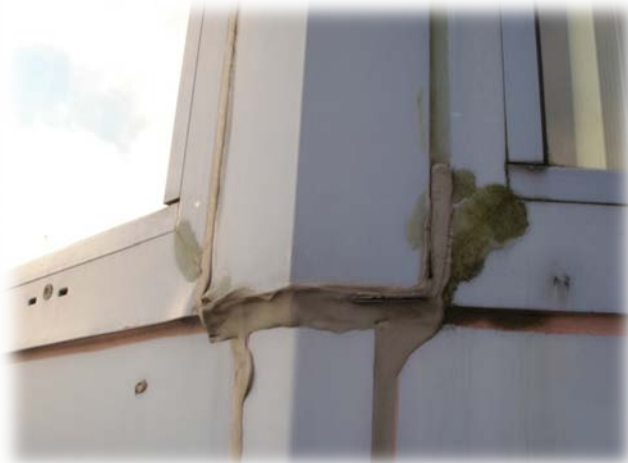
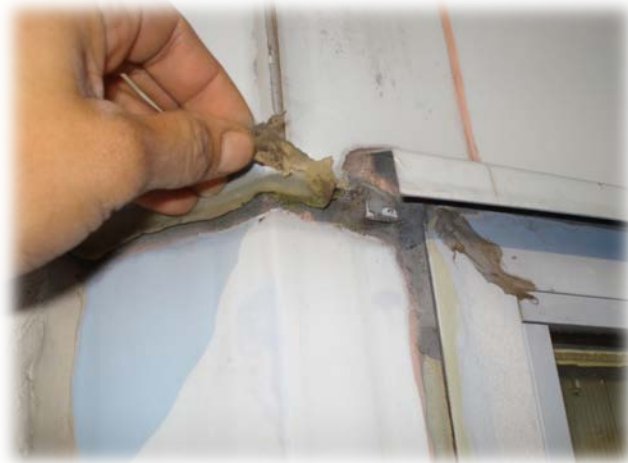
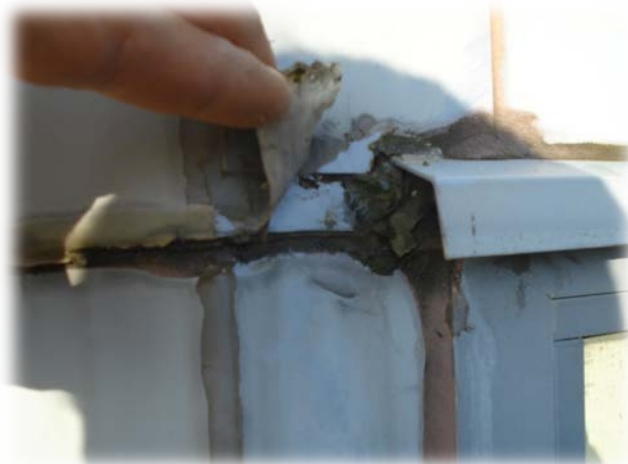
There are many indications of known problem areas that have had temporary repairs.

These repairs do not appear they were performed by a professional. Silicone chalking was placed over old caulking which generally is not expected to hold well as in this case.

This indicates an instance of a repair that is creating another issue - hidden buildup of mold and grime beneath the repair. This could cause larger problems in the future.

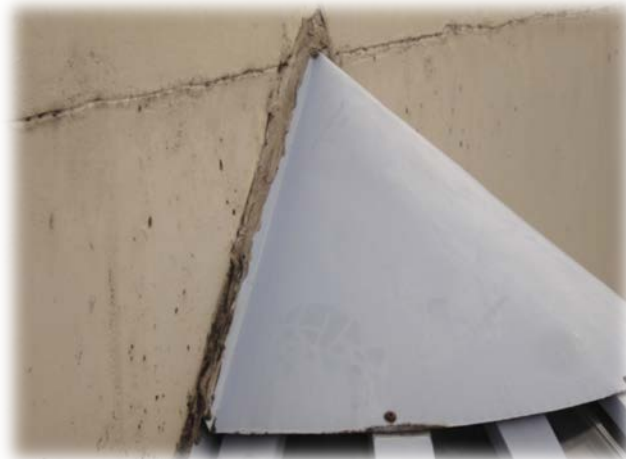
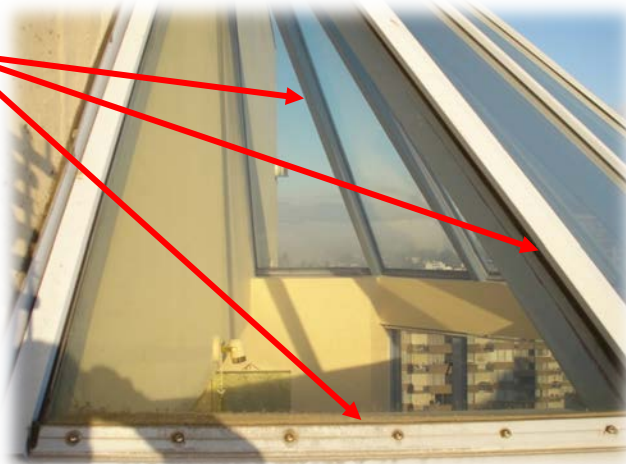
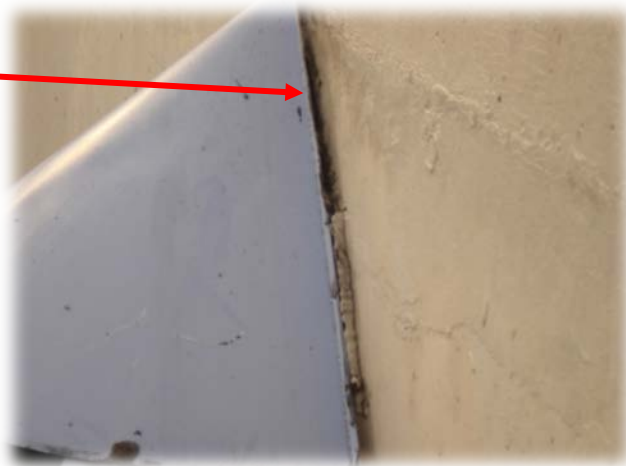
Another place where significant problems were observed is the Turret window assemblies that top the Bay Window columns. These are complicated assemblies of triangular shaped windows with multiple joints in the metal assembly and each junction needing careful sealing.

A crown cap which is attached to the concrete, tops the turrets. This point is one of the most vulnerable on the building with potential to cause problems below. It appears there has been at least one or more past attempts to properly seal the caps.

One of the crown caps was almost completely without sealant and there were significant moisture issues below.

These crown caps and turrets are assessed to be high priority because they have potential for problems that could cause extensive problems in the column of windows below.

- *It is recommended these be thoroughly cleaned and, where applicable, the current sealant removed and new sealant properly applied.*

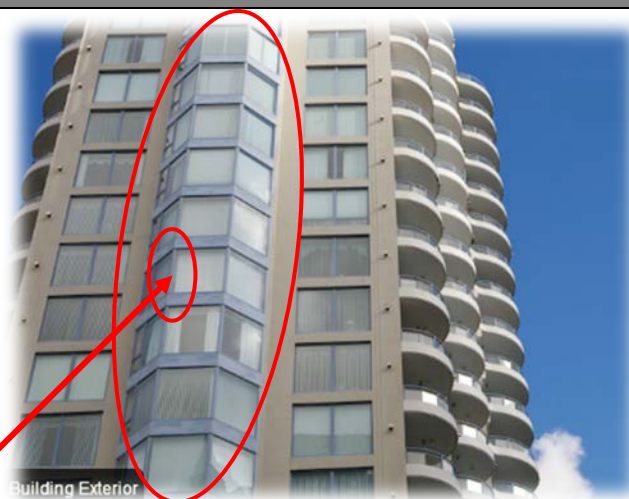
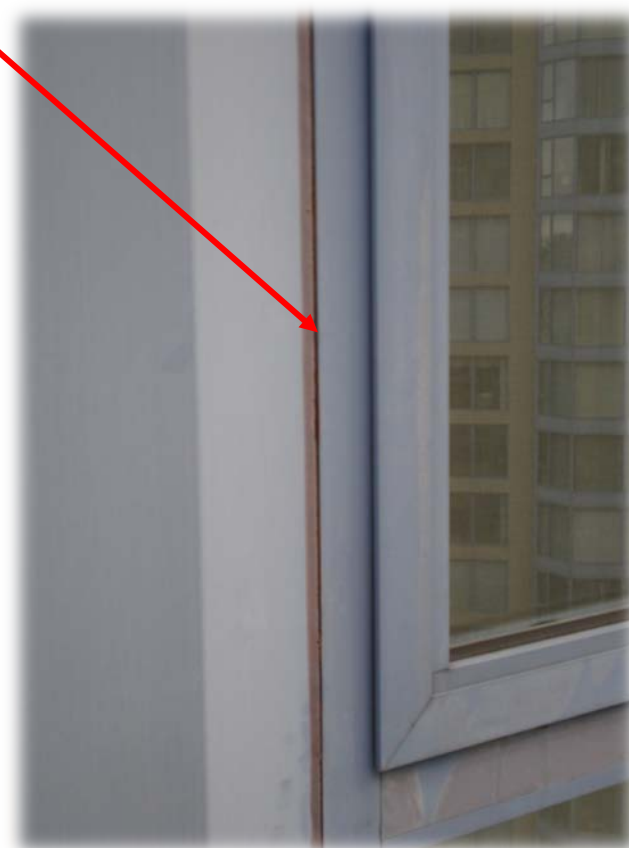
Immediately below the Turrets and Crown caps on the ends of the buildings is the column of Bay Windows and their metal assemblies. These run the entire vertical length of the building and as a whole displayed some persistent problems.

Small but long fault lines in the caulking between the bay's assembled metal pieces were often observed.

If unattended to, these have the potential to expand becoming more significant spaces and causing water to ingress and run into cavities and spaces below. This also has the potential for damage beyond the immediate local.

This was a persistent characteristic and a symptom of some of one of the problems with the bay window units. It is likely in part due to metal's characteristic large range of expansion and contraction. It may also be in part because the amount of sealant applied is relatively thin, not enough to hold as the metal moves.

- *We recommend the Bay Window Assemblies be viewed as a priority for removal of old sealant and new sealant applied.*

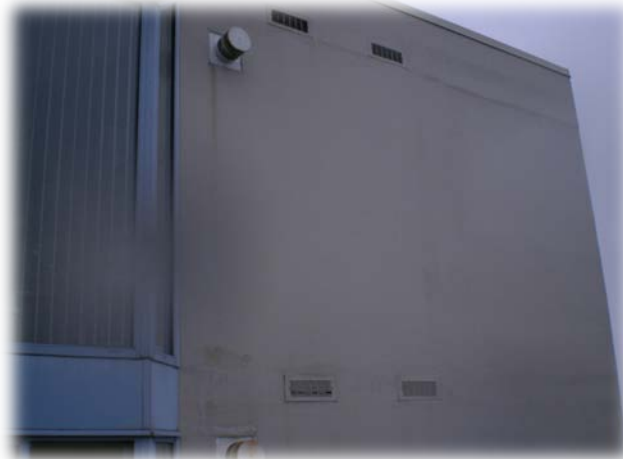
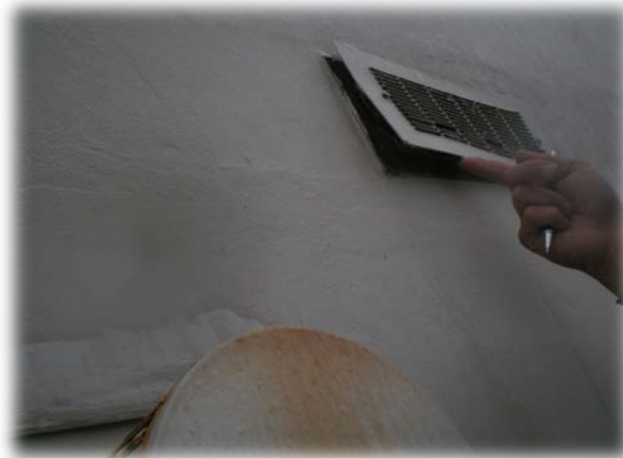
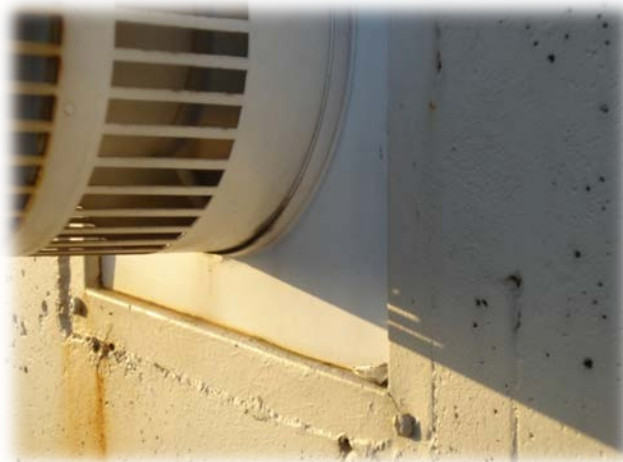
We observed a problem with approximately 16 unprotected air vents on the 21 and 22 floors. These had flat wall mounted covers unprotected by cowling hoods that would shield them from wind and water.

Consequently, most were loose with little to hold them to the wall. Some, as the one pictured on the right, were almost completely loose, easily pryed off the wall with a fingernail. This was likely the cause of water-staining on the ceiling of the room behind it.

It is recommended, cowling hoods be installed around the covers. If required, new flat vent covers should replace those in poor condition.

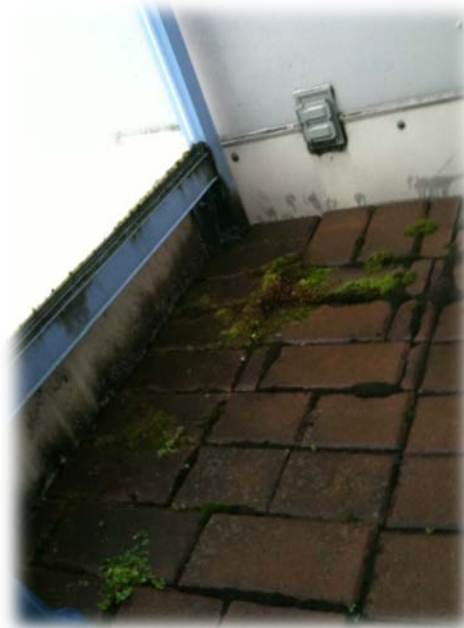
For the most part, the decks and balconies appeared to be in good condition. There were some issues with paint/seal surfaces and with mould, mildew and moss that needed cleaning.

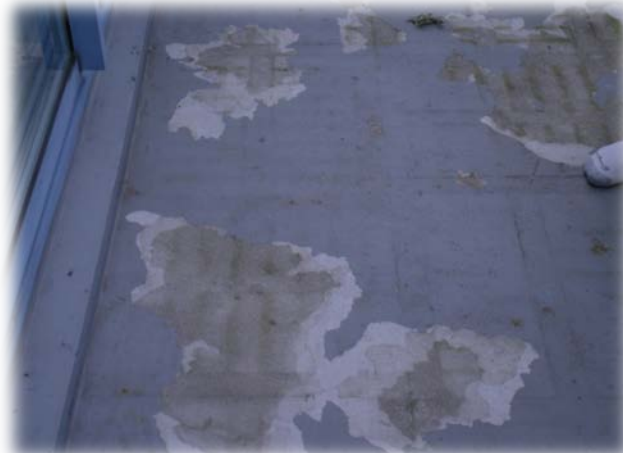
In a few instances, it was noted the sealant surface was wearing off the deck/balcony floors.

A well sealed deck surface helps keep fissures from occurring in the concrete. Fissures that get moisture in can expand due to freezing and other conditions creating larger fissures. A good seal keeps moisture from leaching in and causing the rebar to rust.

It is recommended decks and balconies be pressure washed and those with compromised surfaces be re-sealed.

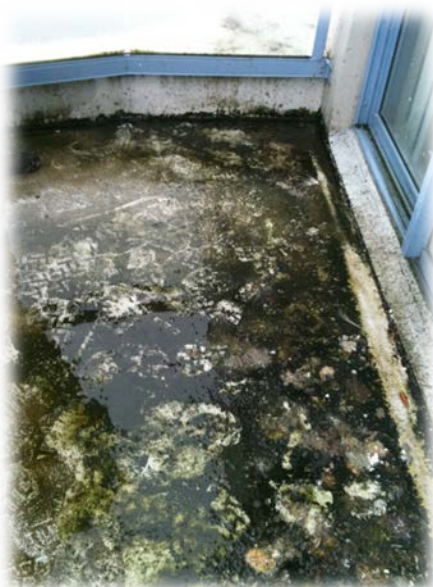
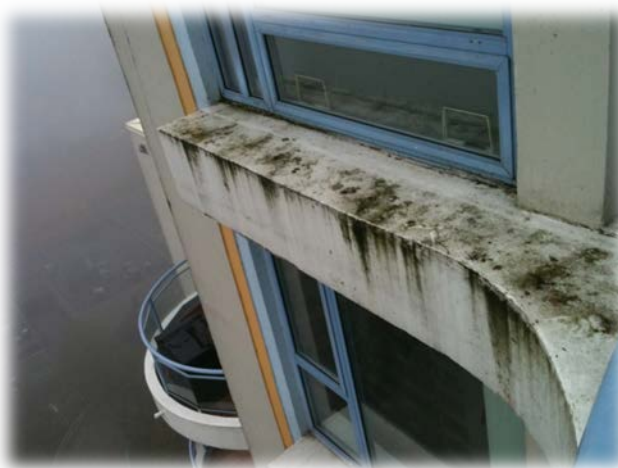
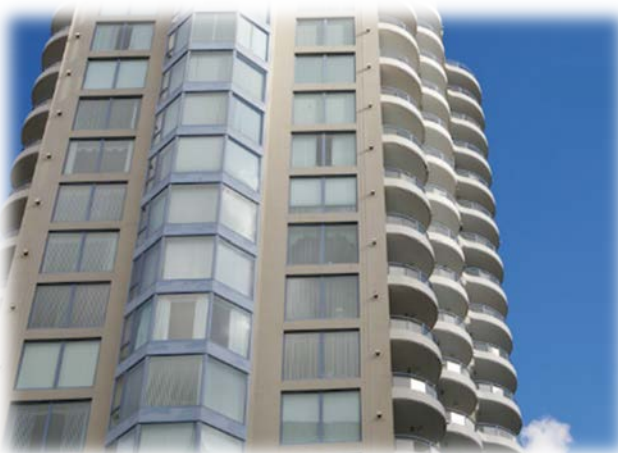
There is considerable dirt, mold and mildew building up on some of the surfaces of the building.

It is recommended these be pressure washed periodically to preserve the integrity of the surfaces and the overall property building values.

To enable economies-of-scale, it is recommended the windows, especially the fixed frame windows and the bay unit windows at the east and west ends be cleaned at the same time as the other work is being performed.

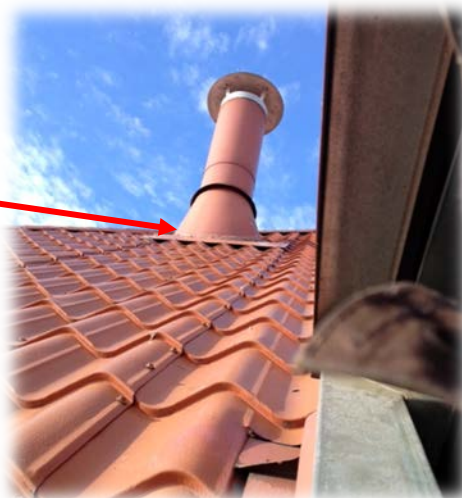
The chimney flashing needs to be re-caulked on the upper-side of the flashing to seal it and prevent it from leaking into the boiler room below.

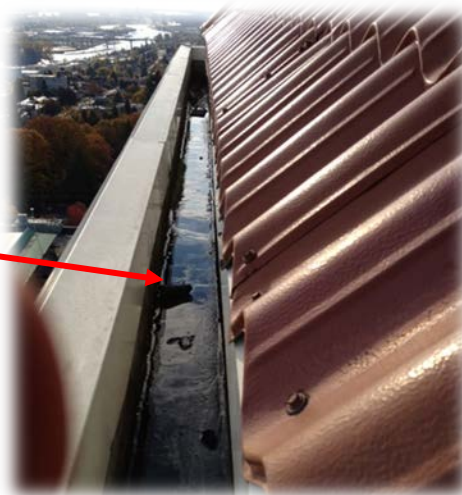
The gutters are performing as expected and the gutter membrane still in good condition. These need periodic cleaning.

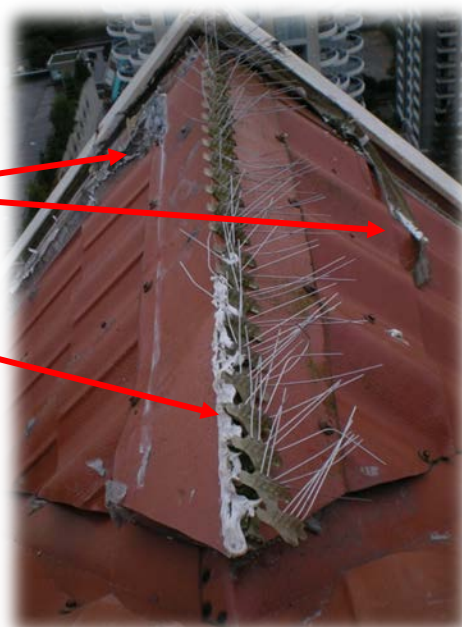
There was one roof location above one of the Penthouse Suites that had experienced considerable damage.

Previous repairs had been attempted using duct tape. As would be expected, these have not held up well.

The roof cap flashing had been badly damaged. This is currently being professionally repaired.

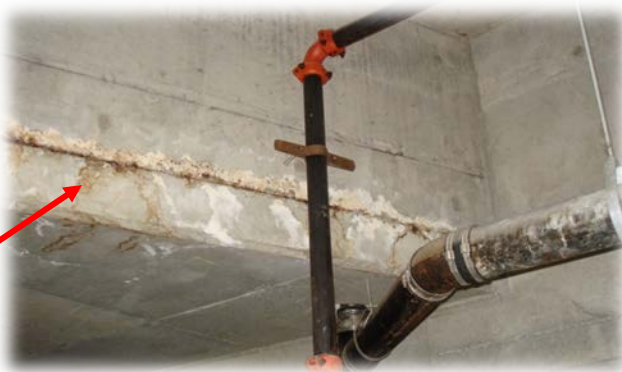
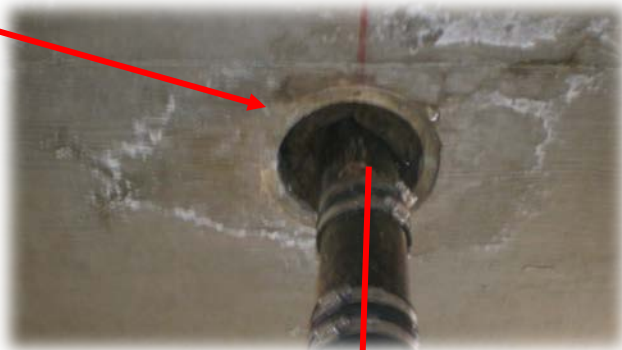
The landscaped area above the underground parking garage is experiencing water ingress problems. There is indication of significant amounts of water leaking through the concrete, and into the garage. There is a considerable amount of rust staining on the concrete on the garage ceiling indicating the water is getting into the rebar and causing rust and indicating deterioration of the rebar.

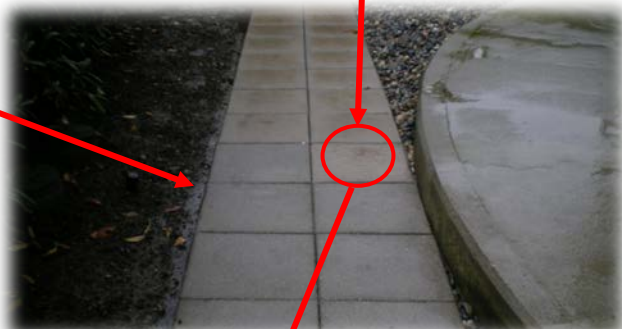
The ground is saturated and pooling in certain areas such as here.

This is not a healthy situation and it is recommended further investigation of the landscaped area above the garage be undertaken to try to determine the locations and causes of the leaks.

Because all the leakage is taking place below the ground level and there is no certain way to determine where the break in the membrane(s) is, it is suggested the only adequate way of finding these and determining the best remedy is to displace some or all of the landscape material and dig down to the concrete surface beneath.

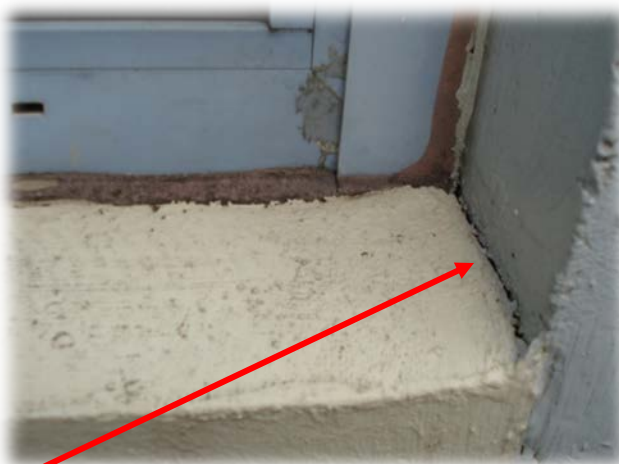
A cold-joint separation at a fixed frame window opening.

In the majority of cases, it is recommended these be ground and filled with an appropriate sealing compound.

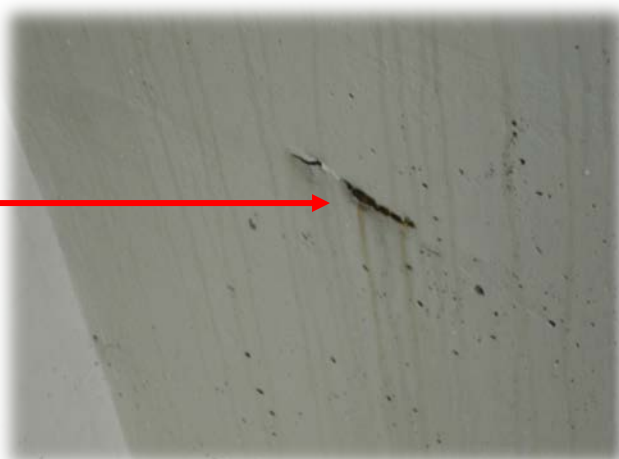
A cold-joint separation at a floor seam. This is open to the rebar as indicated by the rust stain below the fissure.

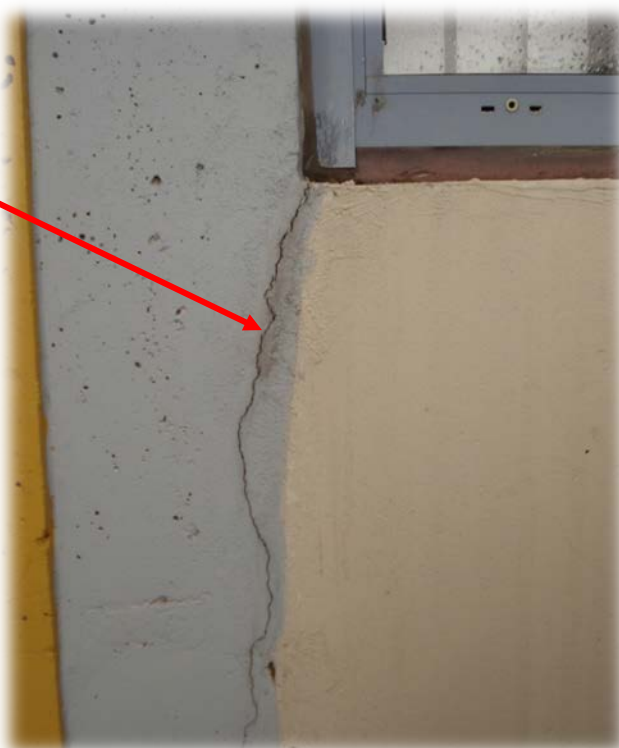
A vertical fracture line starting at the corner of a window frame.
