# Building Defects Inspection Report

This report was prepared May 7, 2012

Assessing the Maintenance Requirements  
for [ ] Condominium and Townhouses in  
Surrey, BC

Prepared for [ ] Property Management Inc.  
Vancouver, BC

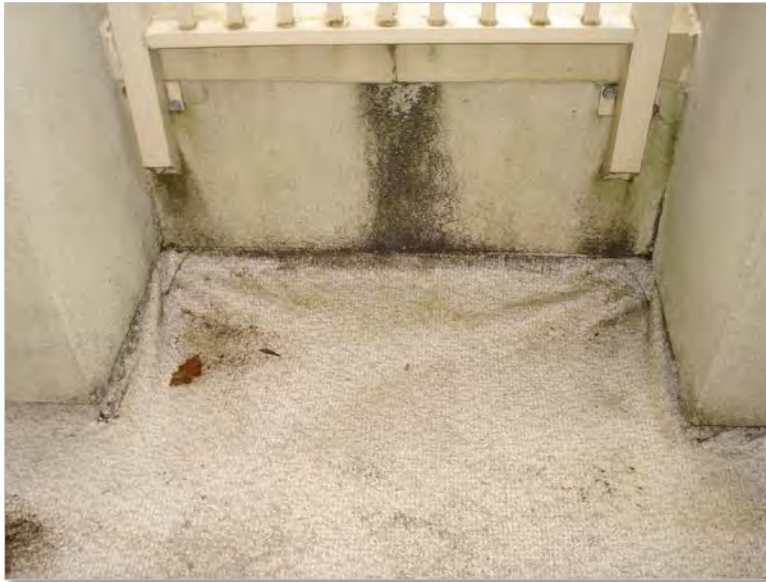
Some decks were quite dirty with mold accumulating and jeopardizing the health of the deck floor membrane.

Some deck membranes were breached allowing water onto the sub-surface through seam separations.

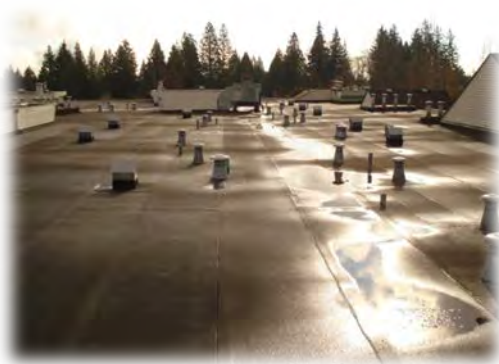
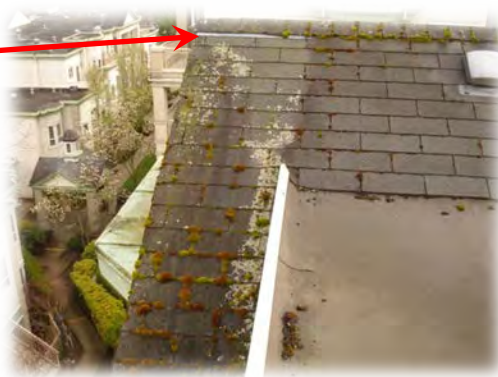
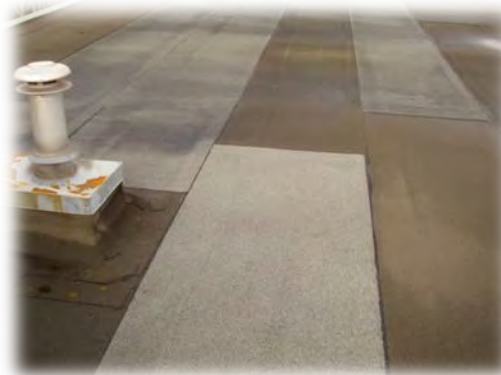
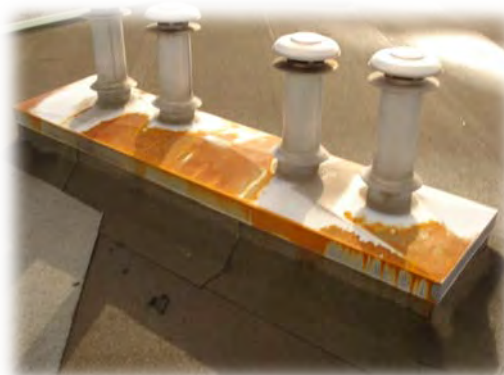
There are **clear signs of wear to the overall area of the roof** including: little or no cover-gravel remaining, top layer of the membrane cracking, seams gapping, membrane lifting and ridging and membrane soft-spots.

A soft spot, with an air pocket beneath and a high risk area for penetration. This should be repaired or monitored routinely.

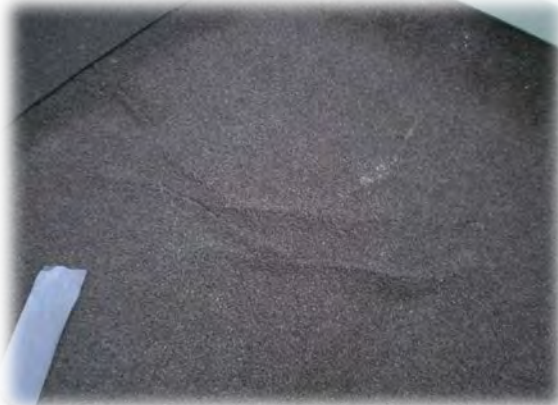
Ridging of the roof layer is prevalent at many locations, with cracks along the tops of the ridges vulnerable to leakage. Continued expansion and contraction of the roof membrane will increase both the prevalence and the severity of this problem.

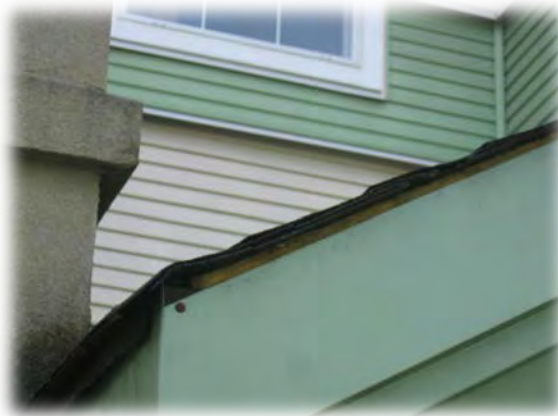
In a few spots the flashing on the fascia board at the end of the roof gables did not fully cover the edges of the Oriented Strand Board roof substrate. This is allowing moisture to absorb into the substrate and the shingles to lift and mold and mildew to grow within the substrate.

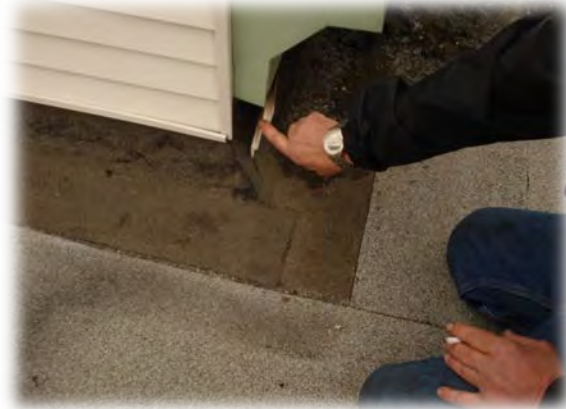
We found details at a few locations where the roof membrane was not properly attached or adhered or missing and allowing exposure of the sub-structure to the weather.

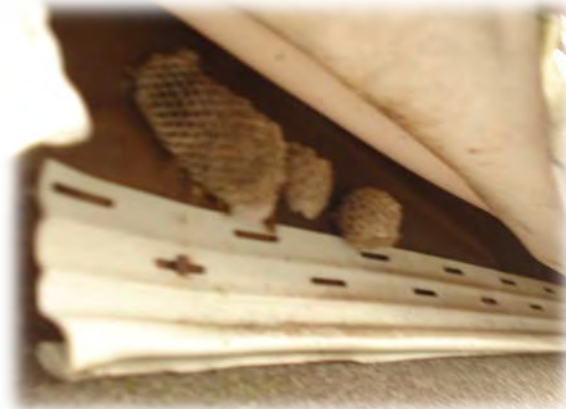
There are a number of instances of melted, curled vinyl siding where due care had not been taken with the hot torch when bitumen roof patches were being torched on. Instances varied in severity and in most cases it did not appear repairs to the damage had been attempted. Some instances were compromising the building envelope. As an example, here, wasps have been hiving under the melted and gaping siding.

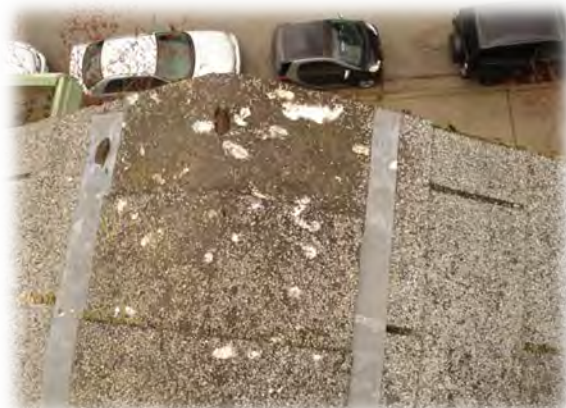
Many of the crown shingles on the gabled roofs are wearing with both holes and cracks occurring in random locations.

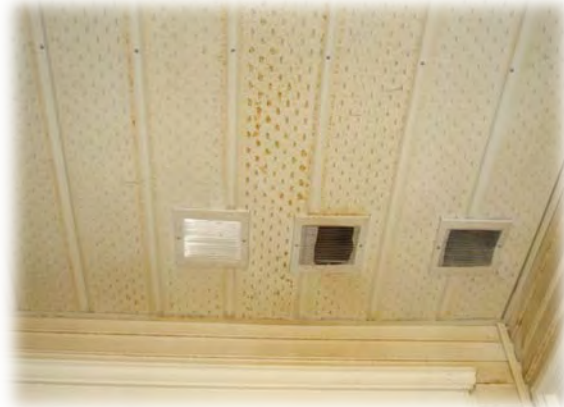
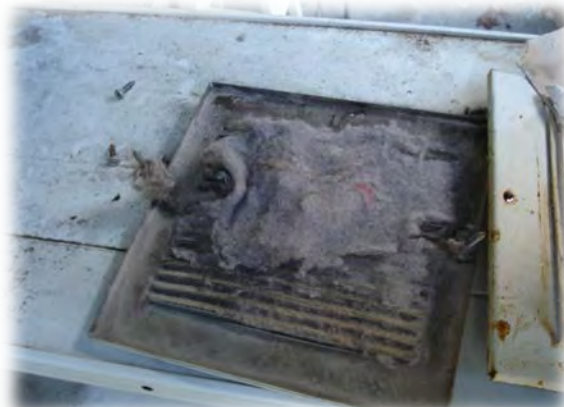
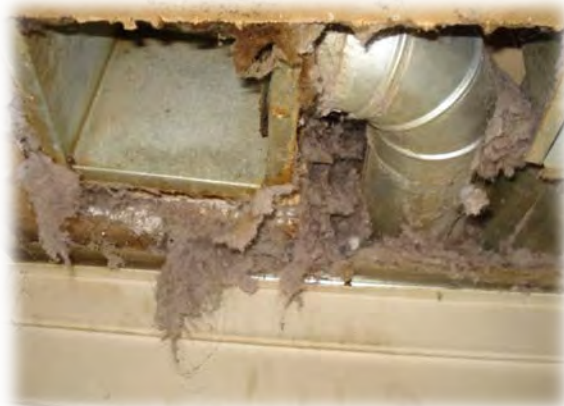
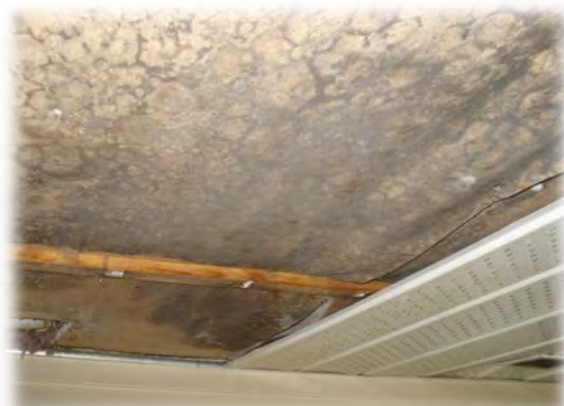
One of the most troubling findings was heavy mold and mildew growth due to excessive moisture in some of the deck soffits.

We noted a number of soffit covers yellowing at the air holes and found excessive moisture accumulating. We opened up only one soffit location and found the extent of the moisture and mold problem fairly extreme.

And, there may be more than one source of the moisture ingress into the soffit space. Potentially, it could be caused by a **leak in the above decking membrane**. It also may be caused by **moisture from interior air exhaust being vented through the soffit** structure including moist air from bathrooms and moist lint-laden air from clothes dryers. And, to exacerbate matters, the method used to satisfy the exterior living space (deck) fire-block requirements, a double sheet of standard gyproc fixed directly above the soffit metal, **completely blocks vital air-flow through the soffits**, eliminating air circulation and **capturing all the moisture within**.

Above the soffit covers, is a double sheet of gyproc used as a fire block for the outdoor living space above. Though there is a ½ inch spacer between the soffit cover and the fire block, it does not provide enough ventilation to carry away the moisture in the soffit. With this fire-block system, any moisture introduced to the soffit cavity above the fire-block has no way to escape.

The gyproc fireblock material in more than one location showed an excessive amount of mold growth presenting risks including structural decay, fire and, potentially, personal health.

1. *Investigate all soffit locations to determine the full extent of the problem.*
2. *Investigate different ways/materials to act as fire block.*
3. *Investigate best practices to ventilate the soffit areas.*
4. *Open all soffit locations and clean out all mold, mildew and decayed material*
5. *Repair all locations as per the recommendations of the intensive investigations.*

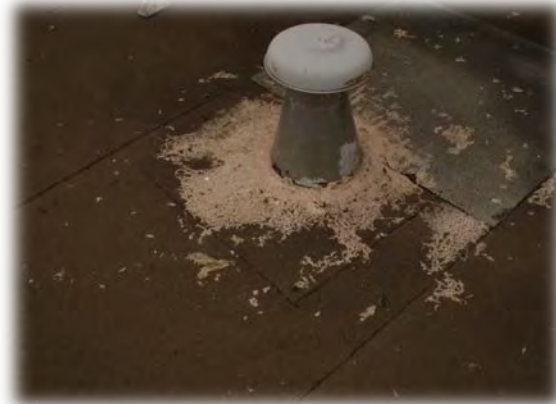
A vent indicating another example of poor clothes dryer filtration.

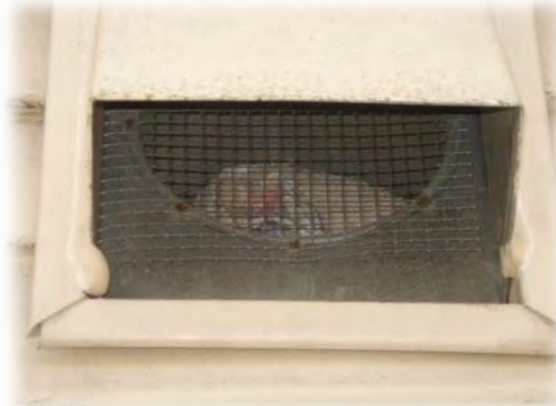
Here it appears a towel has been stuffed into an air vent.

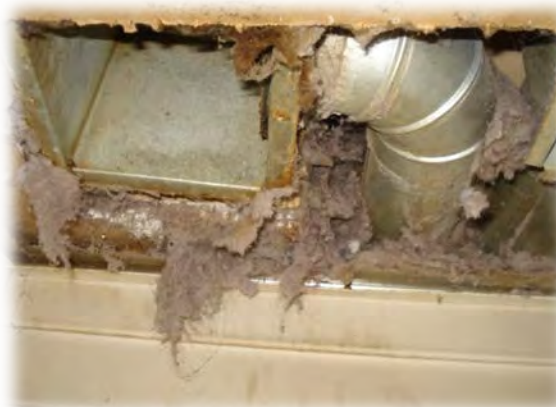
As indicated earlier, extreme buildup in a soffit of lint from a clothes dryer.

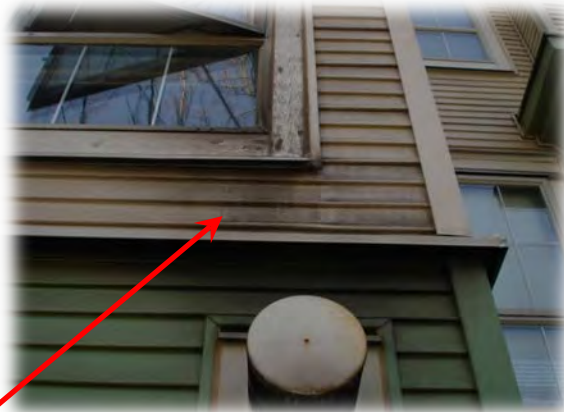
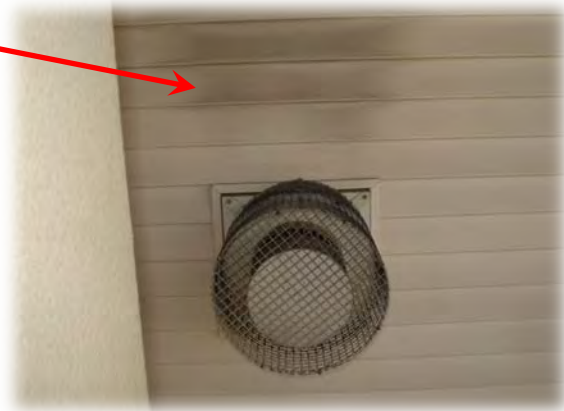
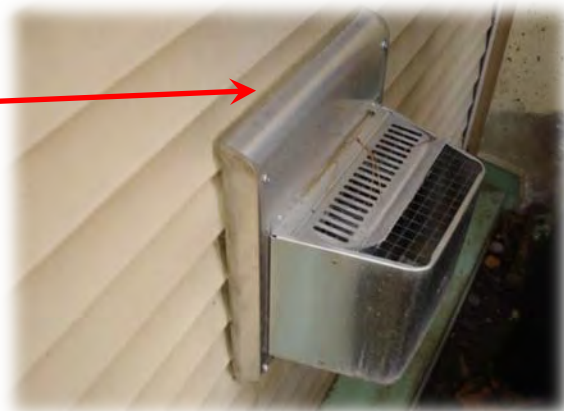
These two pictures indicate soot on the siding and window trim, a sign of excessive particulates being exhausted.

Unlike the original exhaust units that were properly installed into the siding and mounted to the substructure of the wall with flashing protection. This exhaust vent appears to have been retrofitted. We noted there is little protection from water ingress other than a bead of caulking around the perimeter of the exhaust housing and the vinyl siding.

1. *Clean walls where exhaust soot has accumulated.*
2. *Clean and/or paint trim trim that has been affected.*
3. *Advise residents who have indicators of dirty exhaust to have their fireplaces serviced immediately.*
4. *Advise all residents to have their fireplaces serviced regularly.*

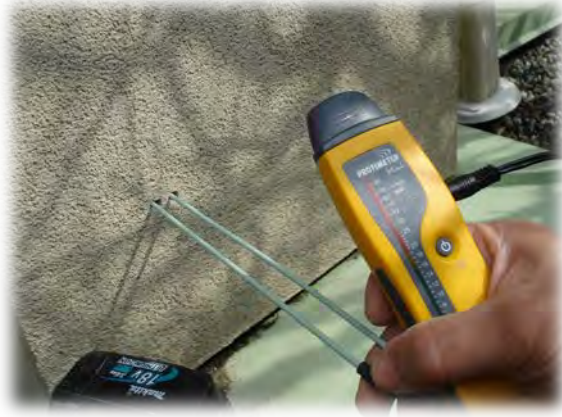
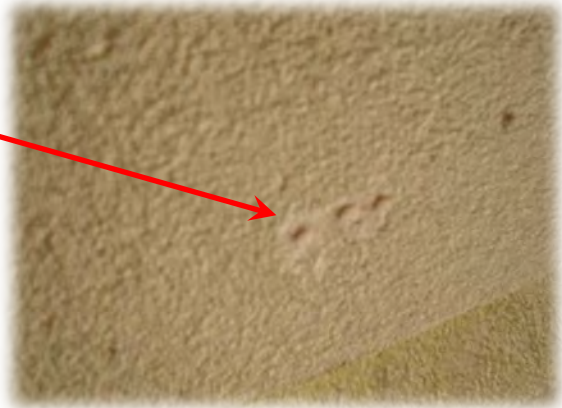
We performed moisture readings at 19 locations including some in locations of previous envelope remediation using a quality commercial grade hydrometer. All readings were within the acceptable range of 11% to 15% moisture content. We suggest this continue to be monitored routinely.

This image is typical of the moisture test drill location holes in the stucco.

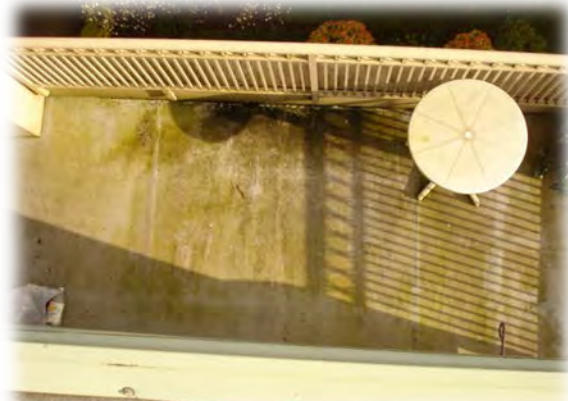
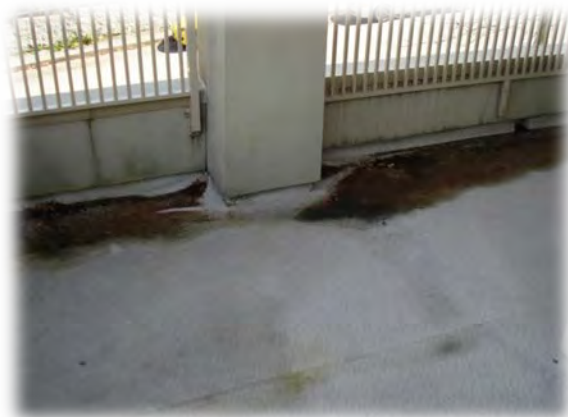
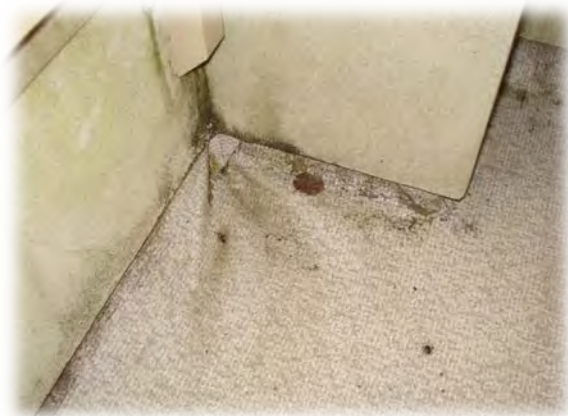
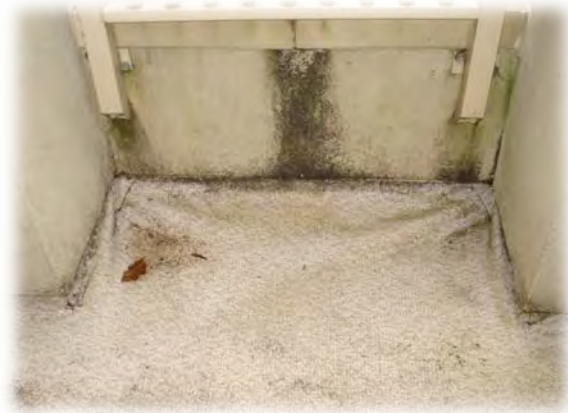
Additionally, some decks had problems with the vinyl decking material lifting or separating from the sub-floor. These decks should have the deck coverings repaired which will most likely entail removal and replacement.

Deck issues are more problematic on the 4<sup>th</sup> Floor decks.

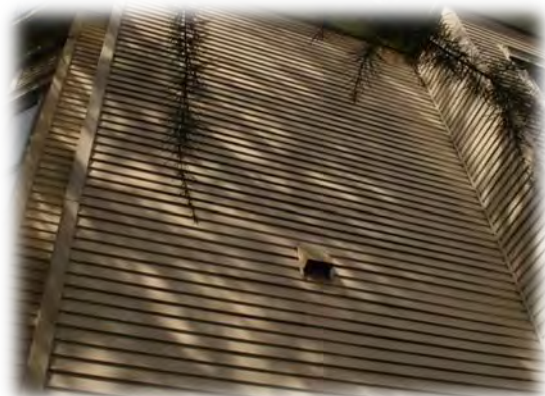
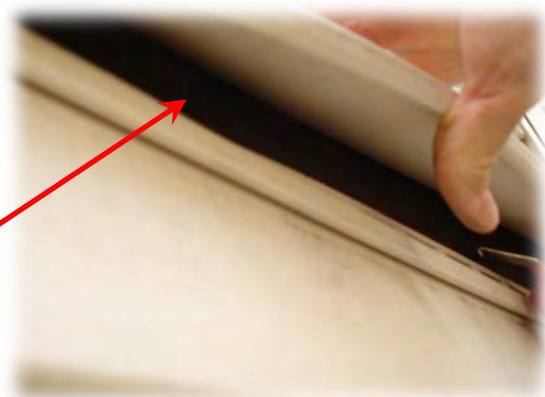
**All Buildings:** The building is a 4 story wood structure. The wood within all wood structures shrink over time approximately ¼ inch per story. Over a span of 4 stories this can amount to a full 1" inch of shrinkage. Since the vinyl siding is relatively stable dimensionally, it will not shrink. As the building shrinks, the siding tends to loosen and in some areas will un-couple, leaving bottom edges of the siding open. We saw this occurring in a few places and recommend those locations be reattached. In some locations, it may require a run of siding be completely removed and re-attached to adjust for the shrinkage.

**West Side:** Siding above amenities room has become unattached. Needs re-attachment and tightening.

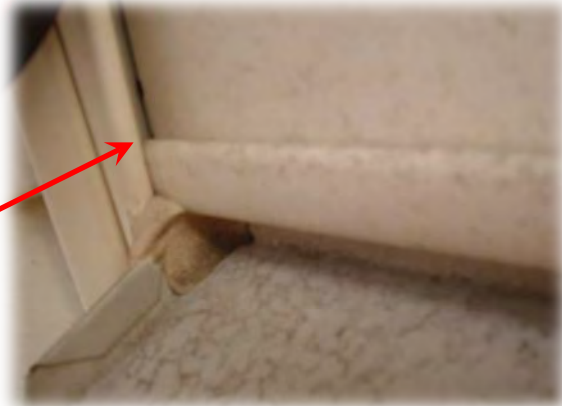
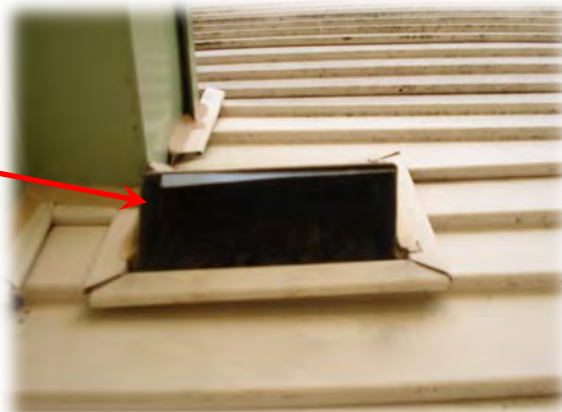
**West Side:** *Dryer vent is 50% plugged. Recommend the vent be unplugged and the occupants use proper lint filtration.*

**West Side:** *End Dam flashing is exposing the wood trim detail which will begin to deteriorate if left exposed. Recommend the flashing be modified to cover the wood trim.*

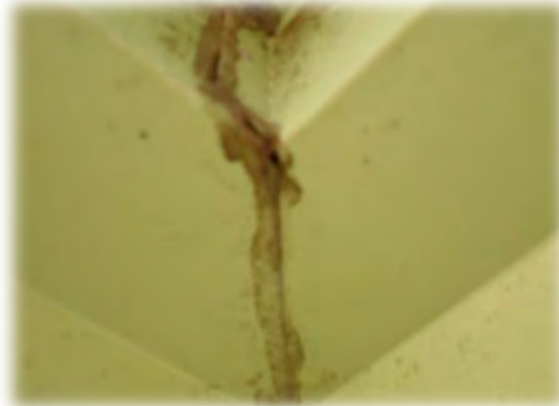
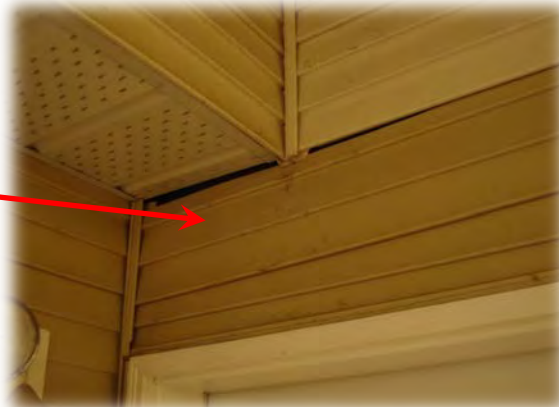
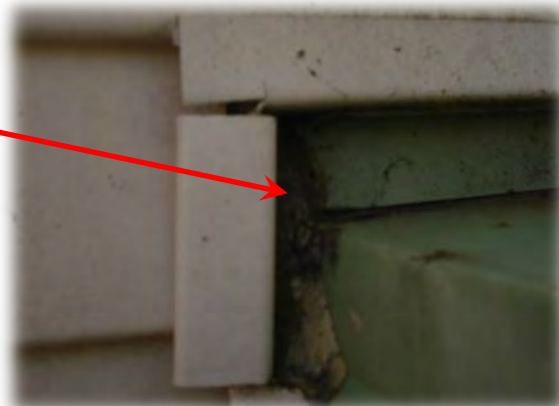
Another typical example of siding detachment seen in numerous places.

Another example of caulking details that have deteriorated leaving the flashing protection compromised.

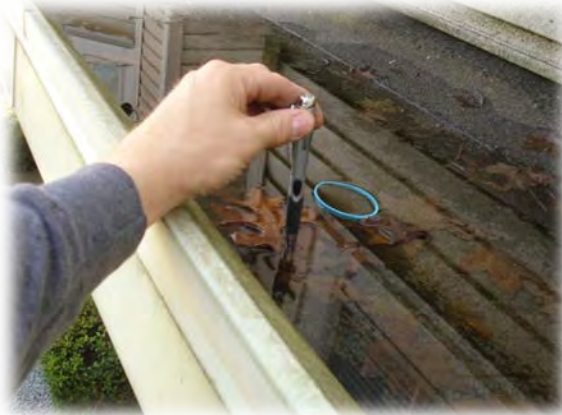
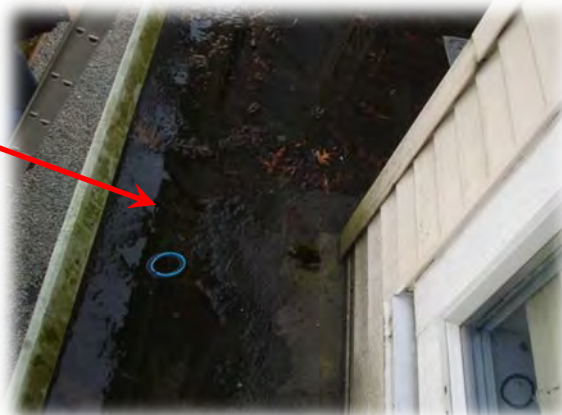
**NE Side:** *Some serious moisture problems were noted at the NE side of the building at Suite 112-113.*

The soffits show dripping and water staining that indicate a significant amount of water seepage.

The drain for the water is at a high point away from the pooling water due to a negative slope to the roof deck.

The roof deck substrate is soft indicating the probable reason for the dripping of the soffits is water may be penetrating the roof membrane into the roof's building structure. **It is strongly recommended this be remediated immediately to ensure the damage does not persist and become worse. It is also recommended all similar portico roofs that show similar standing water and negative sloping be further investigation of similar water ingress problems or potential.**

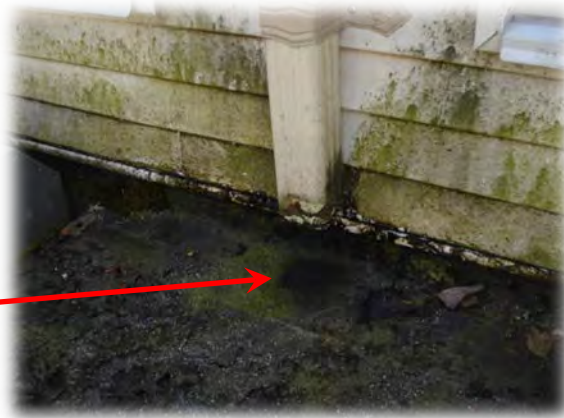
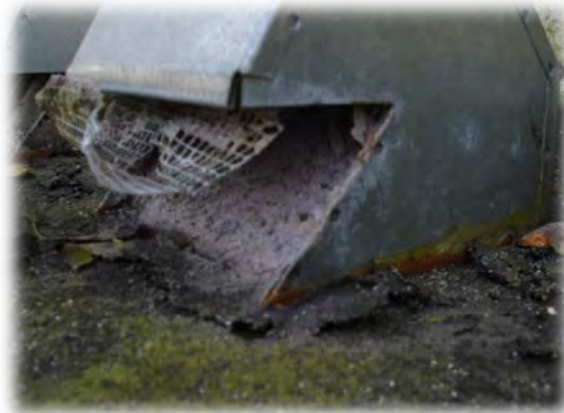
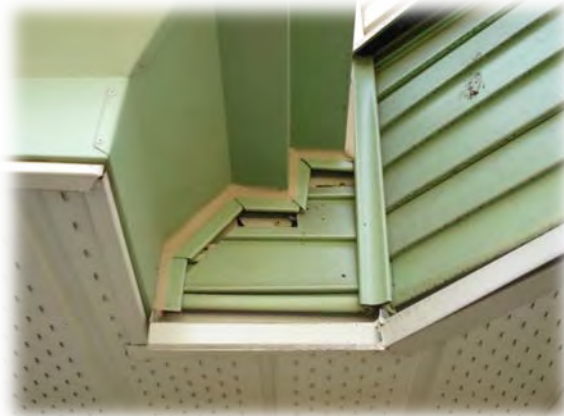
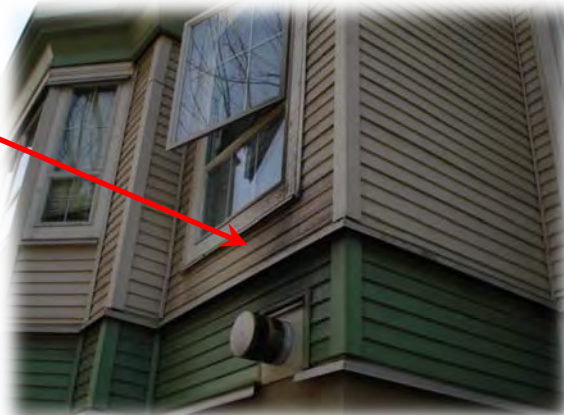
**NE Side:** A similar problem on the portico roof above the entrance of Suites 110-111. A soft roof substrate indicated a probable break and water wicking through the membrane. The wood beneath is likely deteriorating. This could be caused by an inadequate drain deflection pan. The force of the water exiting the drain could be wearing the roof membrane thin. It is recommended the roof be investigated further to determine the extent of the membrane damage and make any repairs required. A more sturdy drain deflection pan should be incorporated into the repairs.

A lint clogged air vent should also be cleaned and repaired.

Siding requires cleaning from a dirty fireplace exhaust.

**It is recommended the siding on all the buildings, and especially the North sides be cleaned.**

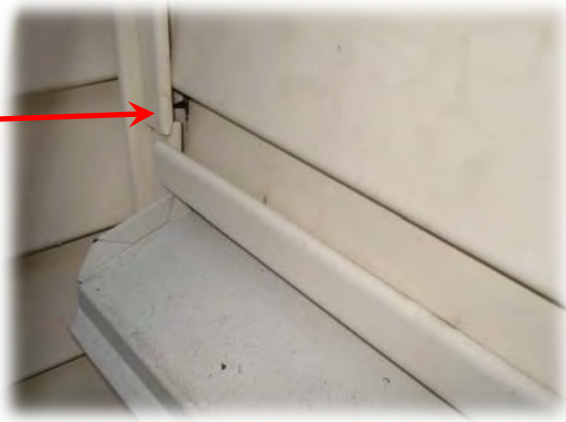
Another example of gaps in J-Mold details that allow water behind the siding and rely on the building paper as the last line of defense

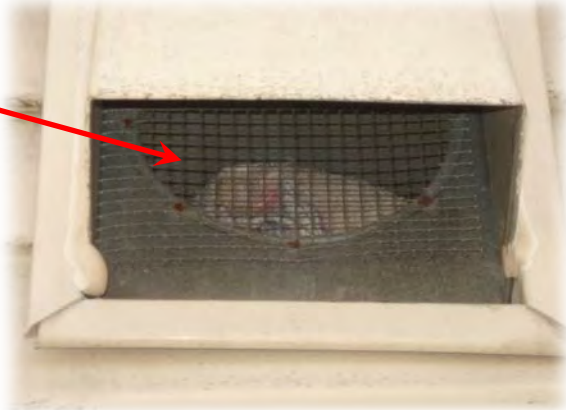
Air vent is 50% plugged.

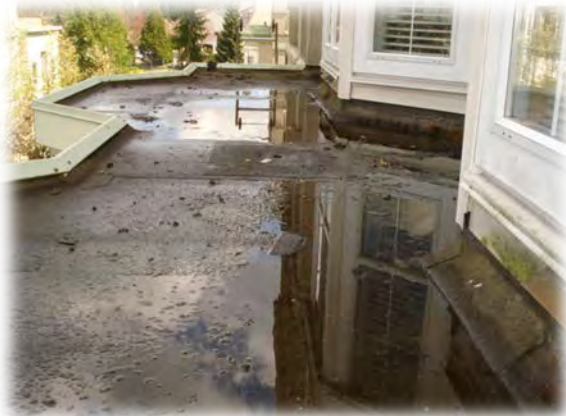
Negative slope on portico roof allowing water to pool.

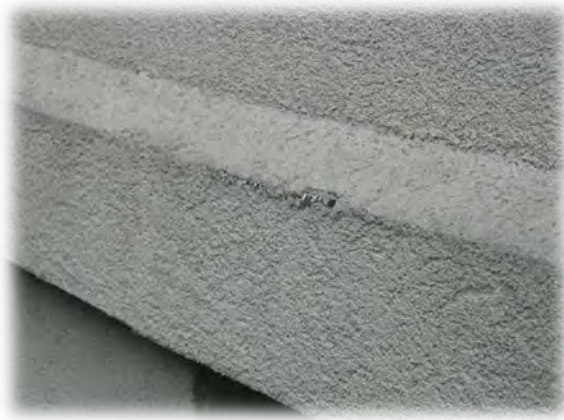
A few instances of holes penetrating the stucco finish.

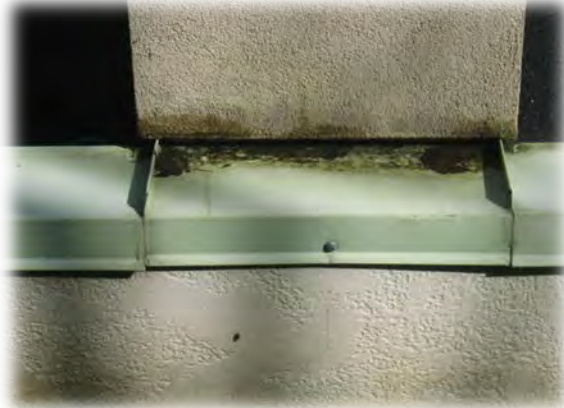
Metal flashing has a negative slope at the base of the pillar allowing water to pool and water to seep into the pillar structure.

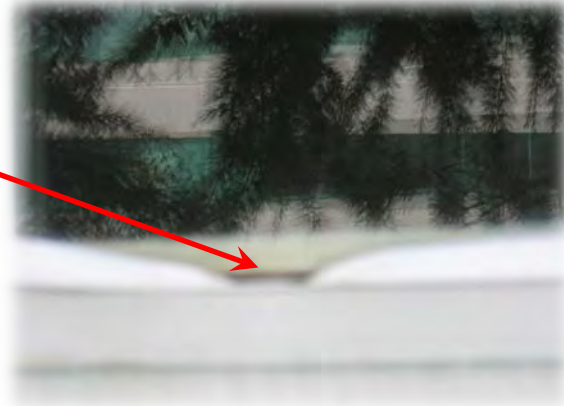
Broken metal trim on 1<sup>st</sup> floor window.

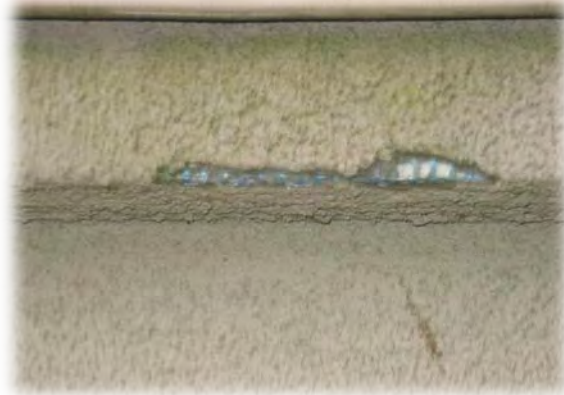
Holes in stucco on 1<sup>st</sup> floor deck.

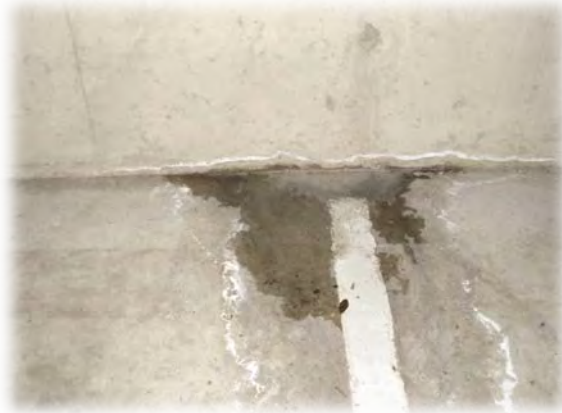
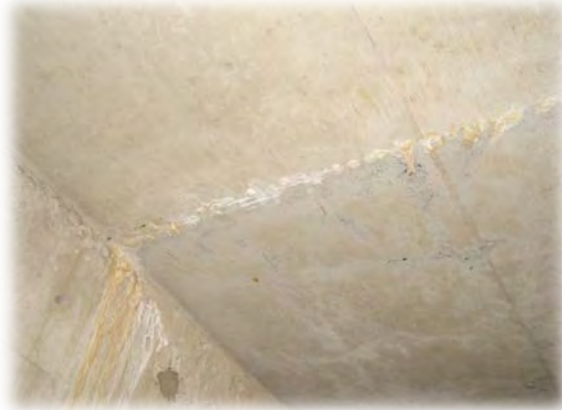
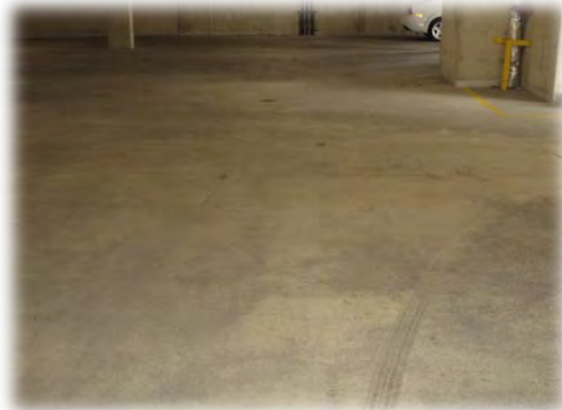
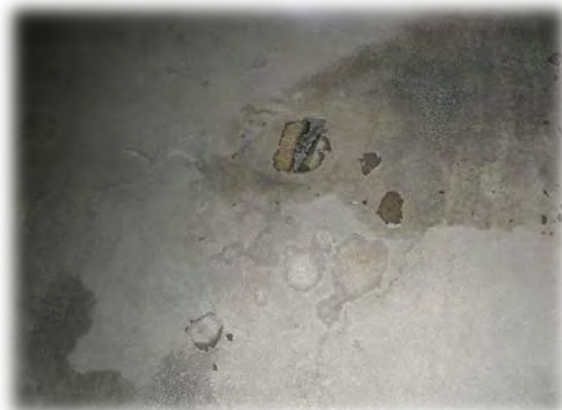
The foundation in general is performing as expected. A few areas need some remediation.

A fracture at a seam in the concrete shows signs of water ingress and should be treated with an epoxy injection to attempt to stop it.

At the main entry to the garage, a high traffic area, the top finish has worn through to the concrete

In the East Parkade, South end, the concrete water seal at a drain is worn down to the concrete and needs to be resealed and finished.
