# Building Maintenance Inspection Report

**Assessing the Maintenance Requirements  
for a High rise Tower  
in British Columbia**

**Prepared for Property Management Inc.**  
Vancouver, BC

... a residential, 24 story concrete high-rise located on the West Coast of BC, the east half tower of a two-tower development, completed in 1996 and now 16 years old.

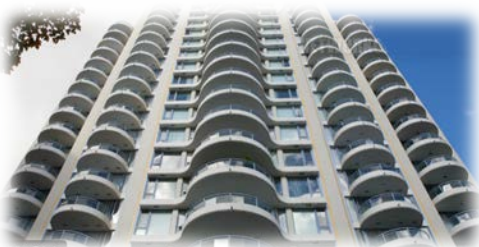
Sealant and Caulking Details	
<p>We observed the 16-year old sealant is in fair condition and to be, on average, at approximately 75% of its full live-span.</p> <p>Sealant bead-lines for concrete to flashing joints, as shown here, are typically <math>\frac{3}{4}</math>" in wide and holding relatively well.</p>

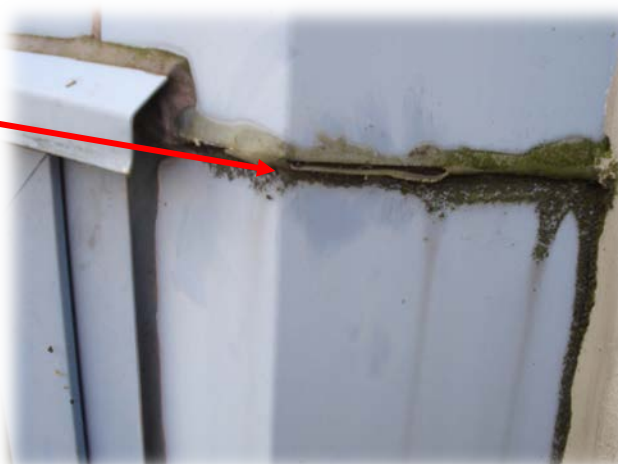
There are many indications of known problem areas that have had temporary repairs.

These repairs do not appear they were performed by a professional. Silicone chalking was placed over old caulking which generally is not expected to hold well as in this case.

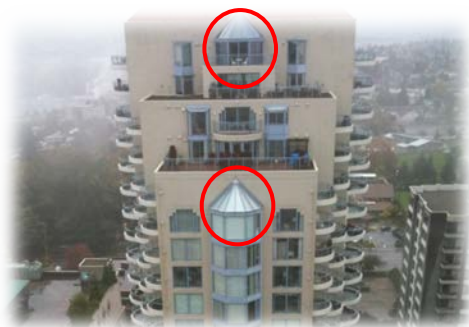
## Bay Window Turrets

**Bay Window Turrets:** Of particular note are the Bay Windows on the East and West ends of the building. These are vulnerable to considerable damage and leakage from seriously compromised caulking and seals. The column of bay windows runs the entire length of 19 floors and is topped with an angled glass turret. The turret is crowned with a small but important cap flashing. The sealant for the turrets and their crown pieces are notably weak and there is leakage occurring now with the potential for significant leakage at any time in the future. Each suite in the length of the entire column of bay windows is vulnerable to water ingress as a consequence.

Another place where significant problems were observed is the Turret window assemblies that top the Bay Window columns. These are complicated assemblies of triangular shaped windows with multiple joints in the metal assembly and each junction needing careful sealing.

A crown cap which is attached to the concrete, tops the turrets. This point is one of the most vulnerable on the building with potential to cause problems below. It appears there has been at least one or more past attempts to properly seal the caps.

- *It is recommended these be thoroughly cleaned and, where applicable, the current sealant removed and new sealant properly applied.*

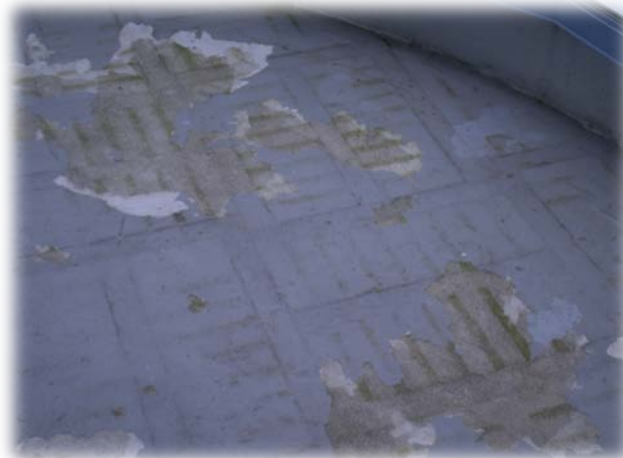
A well sealed deck also helps is easier to keep clean and resists mold and mildew from cultivating and damaging the surface of the concrete.

It is recommended decks and balconies be pressure washed and those with compromised surfaces be re-sealed.

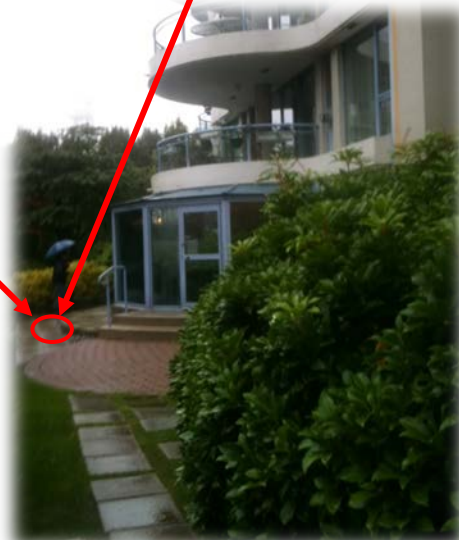
**Landscaping and Foundation:** There is a leak at one or more of the drain pipes, as well as various places in the concrete cold-joints of the landscaped terrace foundation, above the underground parking garage. The solution will likely require removal of existing landscape and soil. Remove deteriorated waterproof membrane, repair membrane on structural concrete slab and place new drainage material prior to placing soil and re-landscaping

This is not a healthy situation and it is recommended further investigation of the landscaped area above the garage be undertaken to try to determine the locations and causes of the leaks.

Because all the leakage is taking place below the ground level and there is no certain way to determine where the break in the membrane(s) is, it is suggested the only adequate way of finding these and determining the best remedy is to displace some or all of the landscape material and dig down to the concrete surface beneath.
